SUBJECT: NATIONAL BRIDGE INSPECTION STANDARDS (NBIS)
BRIDGE INSPECTION REPORTS

W-14-007

(44B) CHEQUSST NCK / HERRING RIVER

STRUCTURES INSPECTION FIELD REPORT

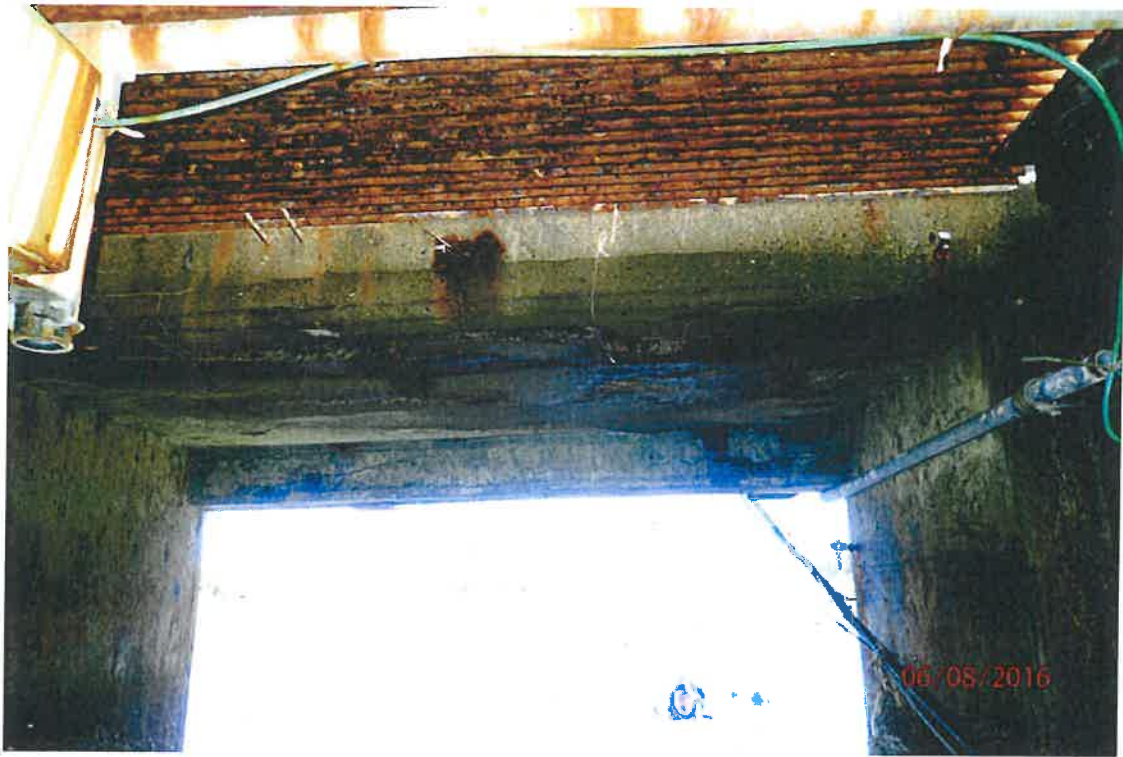
Adjacent to steel grate, the roof has light cracking, moderate delamination, and rust staining 3.3' L x 6.0' W.

Photo 1: Roof of south upstream flume extension.

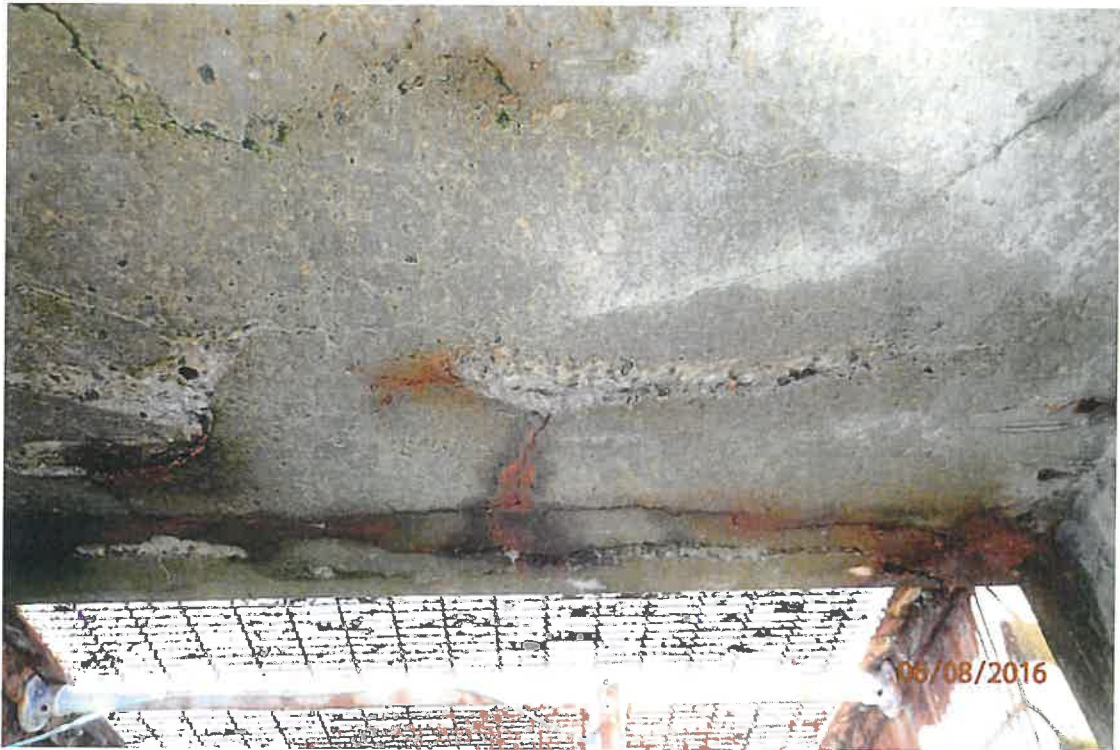
Photo 2: Roof of south upstream flume extension looking west.

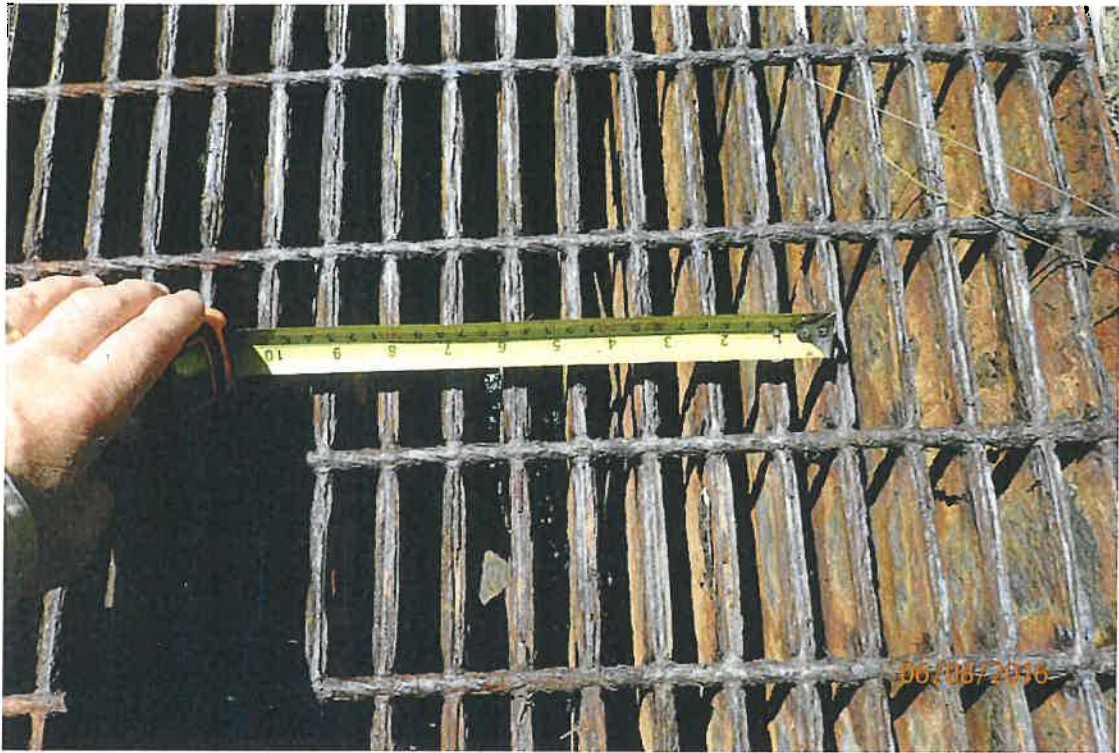
- Some locations have severely deteriorated steel grating that deflects easily under foot.
- The SE grating has heavy rust at the west side, photo 3.
- The remaining gratings have moderate rust.

Photo 3: Grating over south upstream flume extension.

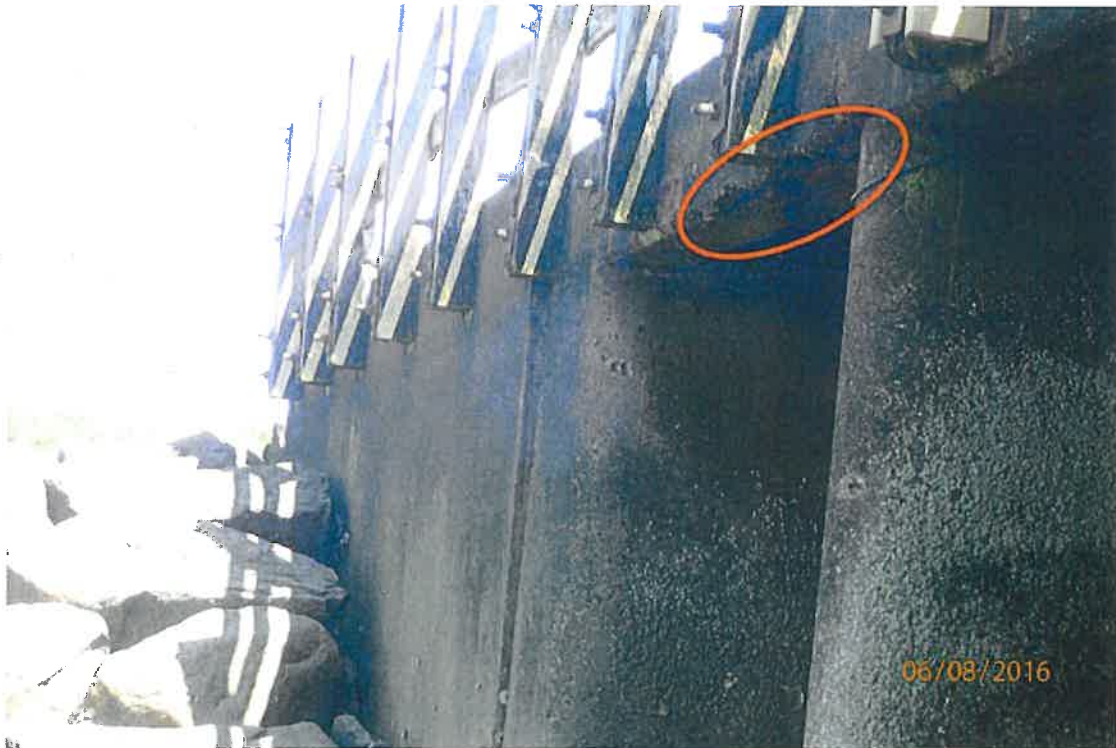
The bottom of west headwall north barrel has a spall on bottom with exposed rebar 3' W x 0.3'H x 0.8' D, photo 4.

Photo 4: Headwall of downstream flume extension has spall.

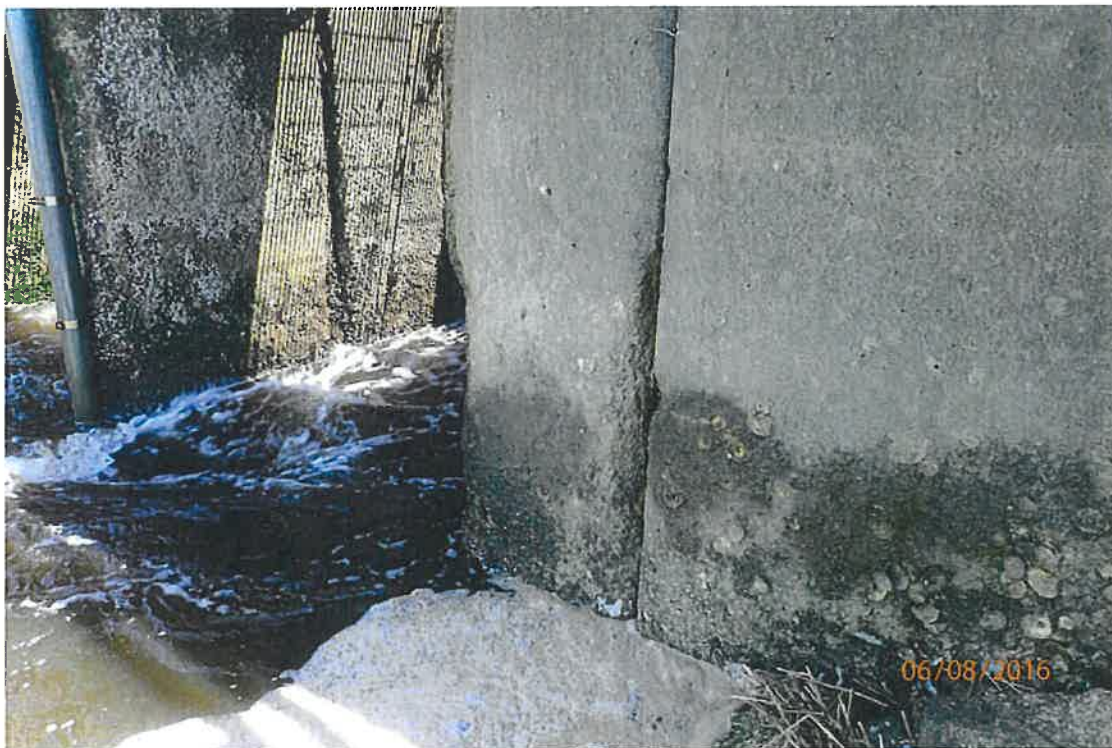
Photo 6: Spalls on downstream south barrel south wall.

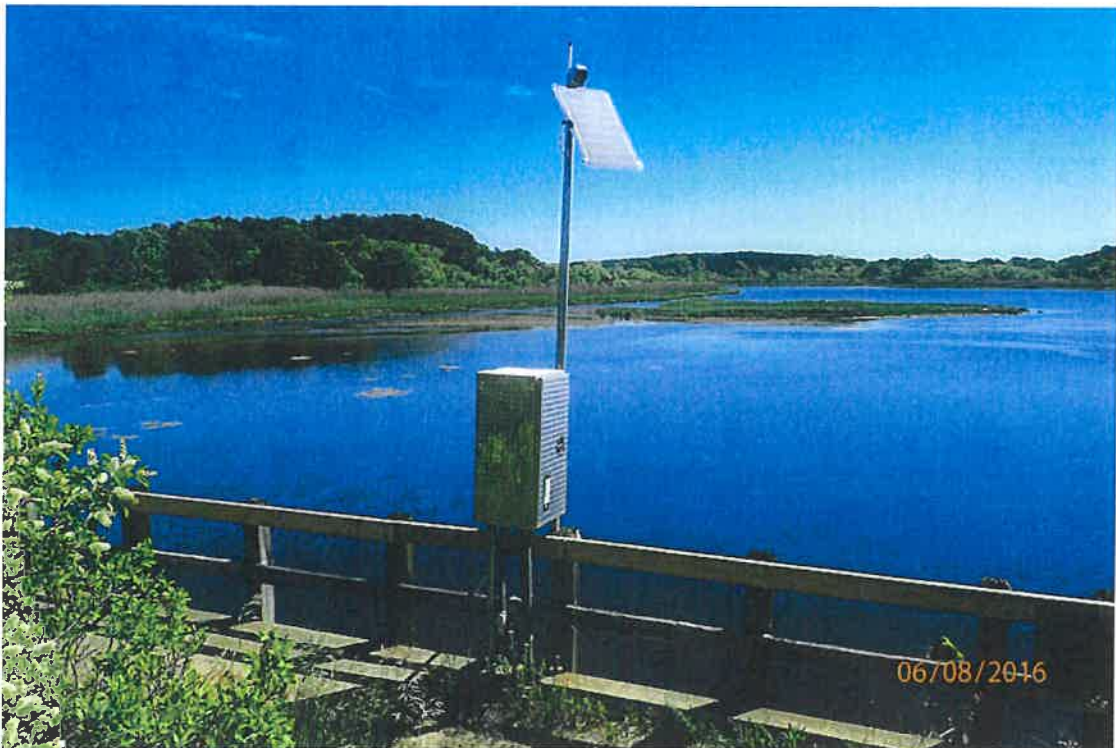
Photo 12: Rail has been repaired at east.

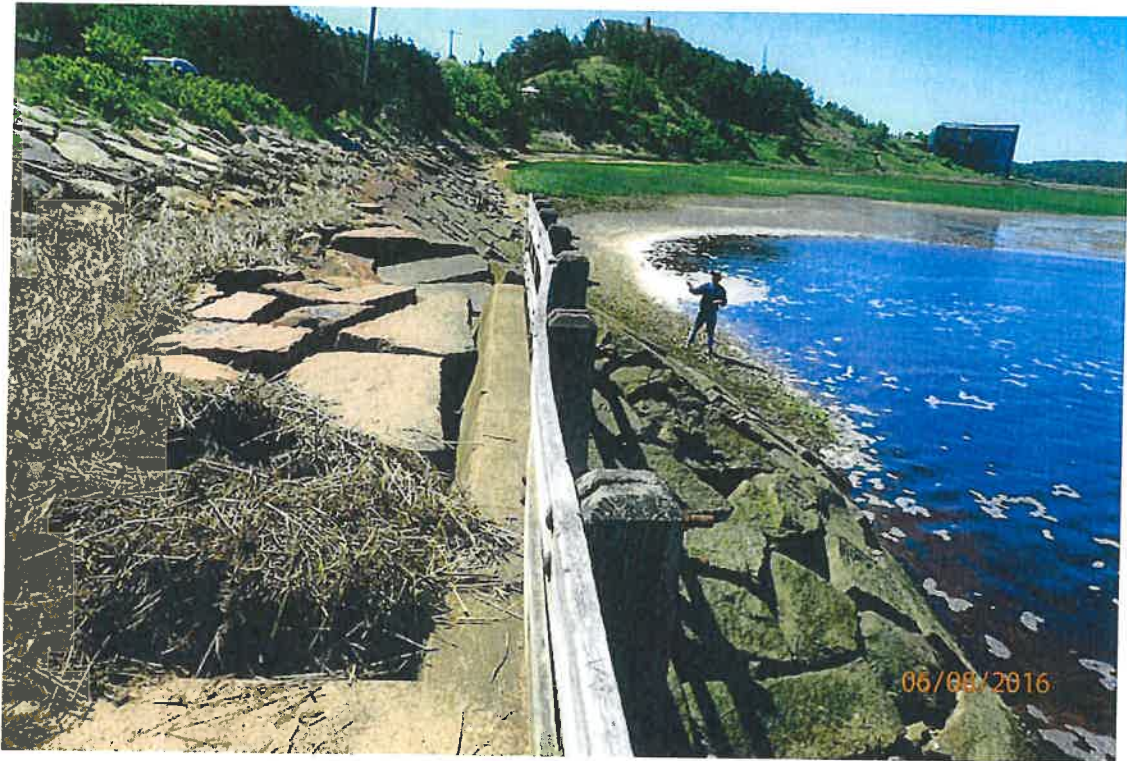
Wingwall displacements are consistent with settlement /rotation of the spread footing type construction, photo 13.

Wingwall Displacements (at top):

SW 2-1/2"

NW 3"

NE 2-1/2"

SE 1-1/2"

Photo 13: Typical deflection of rail following settlement of wingwalls on flume extension.

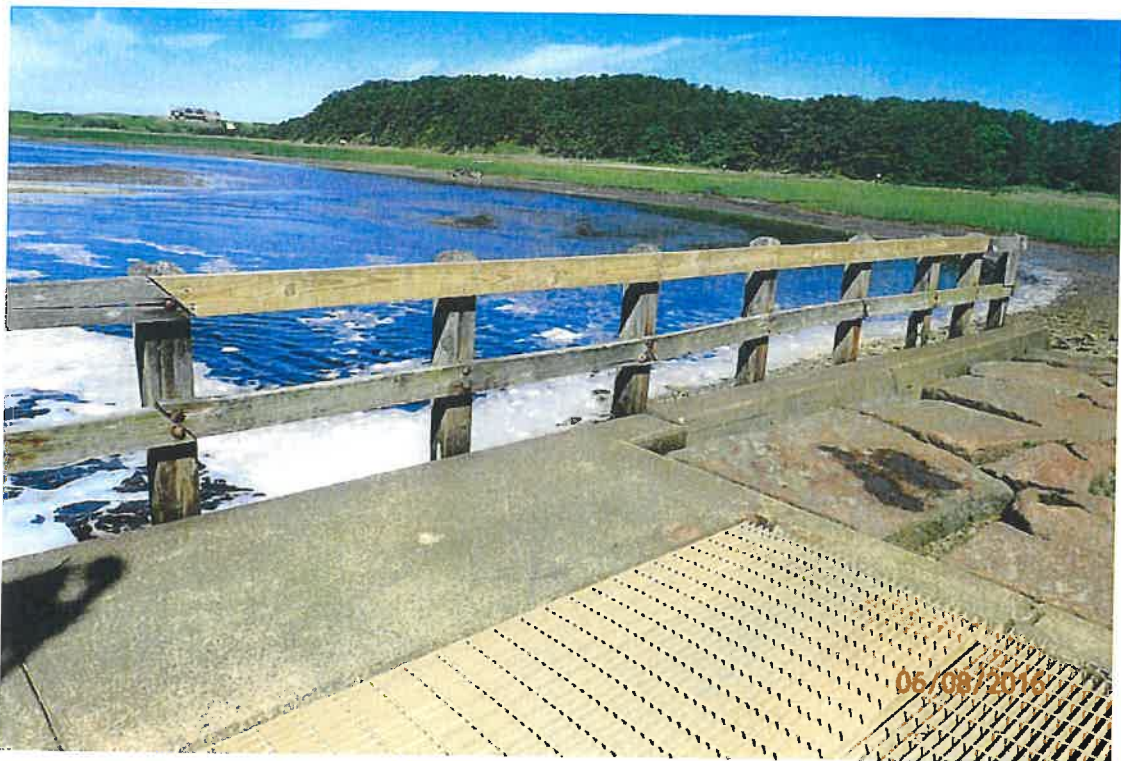
Photo 14: Rail at west has been repaired.

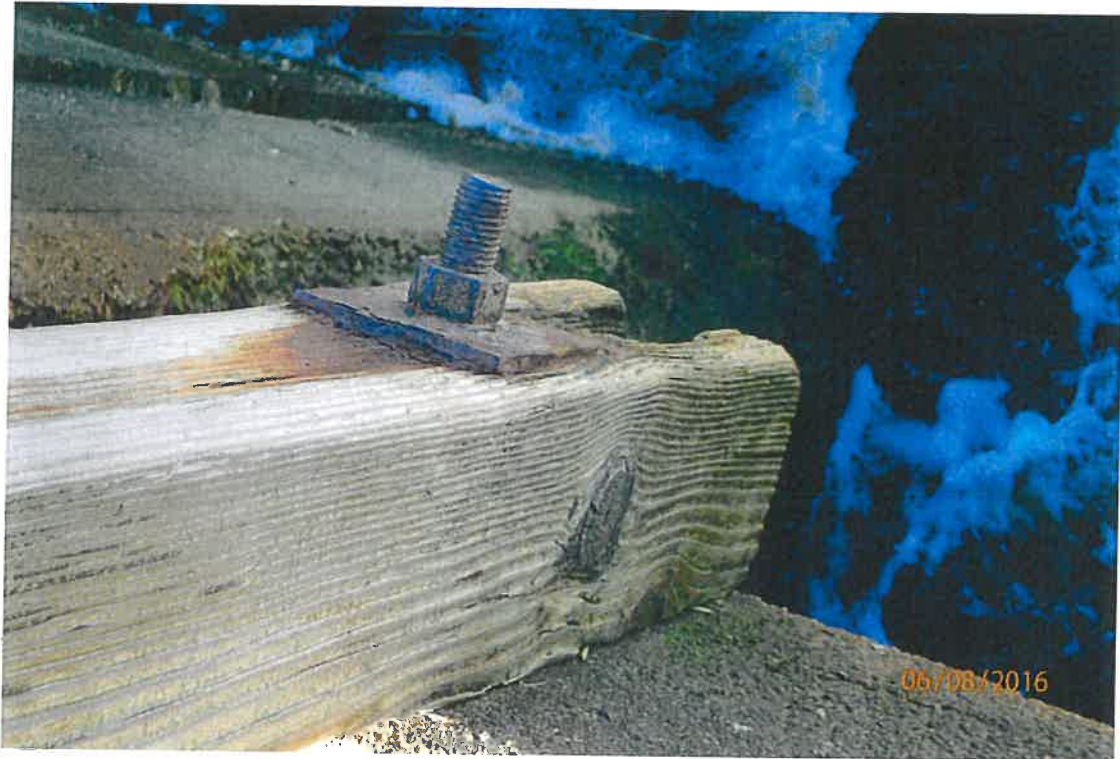
- The railings are firmly attached but most of the posts are split near the top, some with full height splits most likely to pack rust on the upper bolts, photos 16 & 17.
- West side, 7th timber post from the south has heavy rot with the bottom bolt is missing, photo 15.
- The railings are displaced outward with the wingwalls, photo 13 typical.
- Top rail at the east has been repaired, photo 12.
- Many fasteners have heavy deterioration.
- A top section of the west railing has been repaired, photo 14.

Photo 15: West side, 7th post from the south has missing anchorage on the bottom.

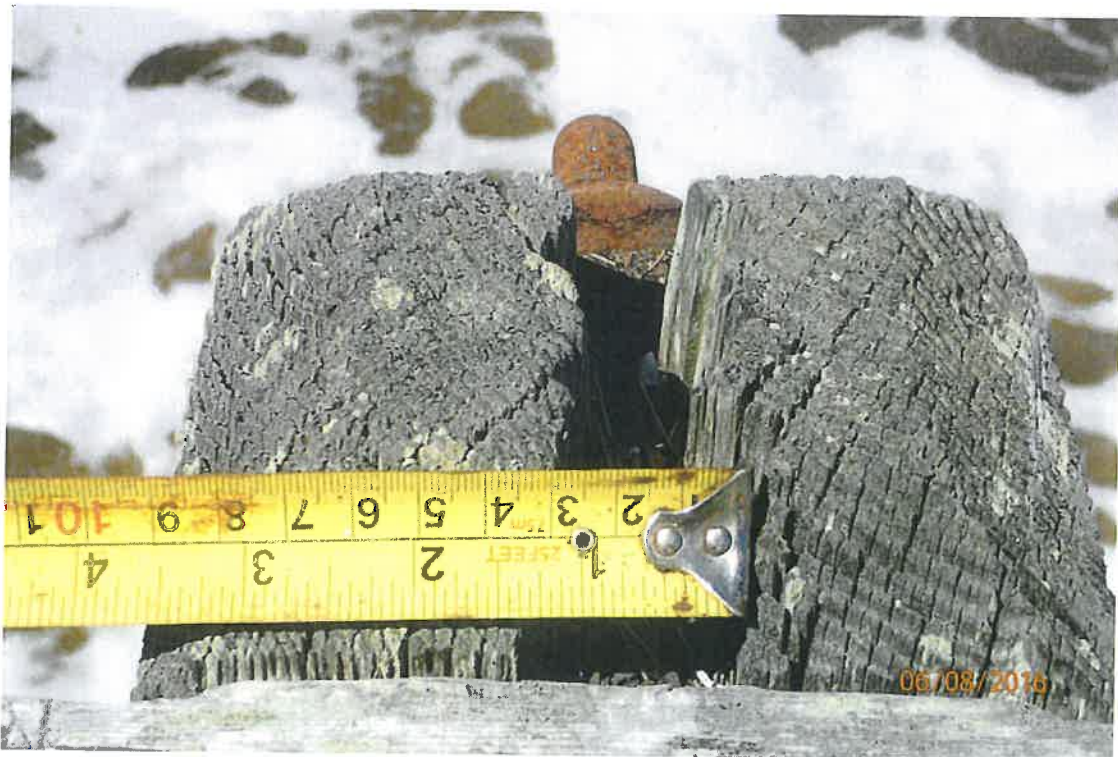
Photo 16: Typical spit in rail post

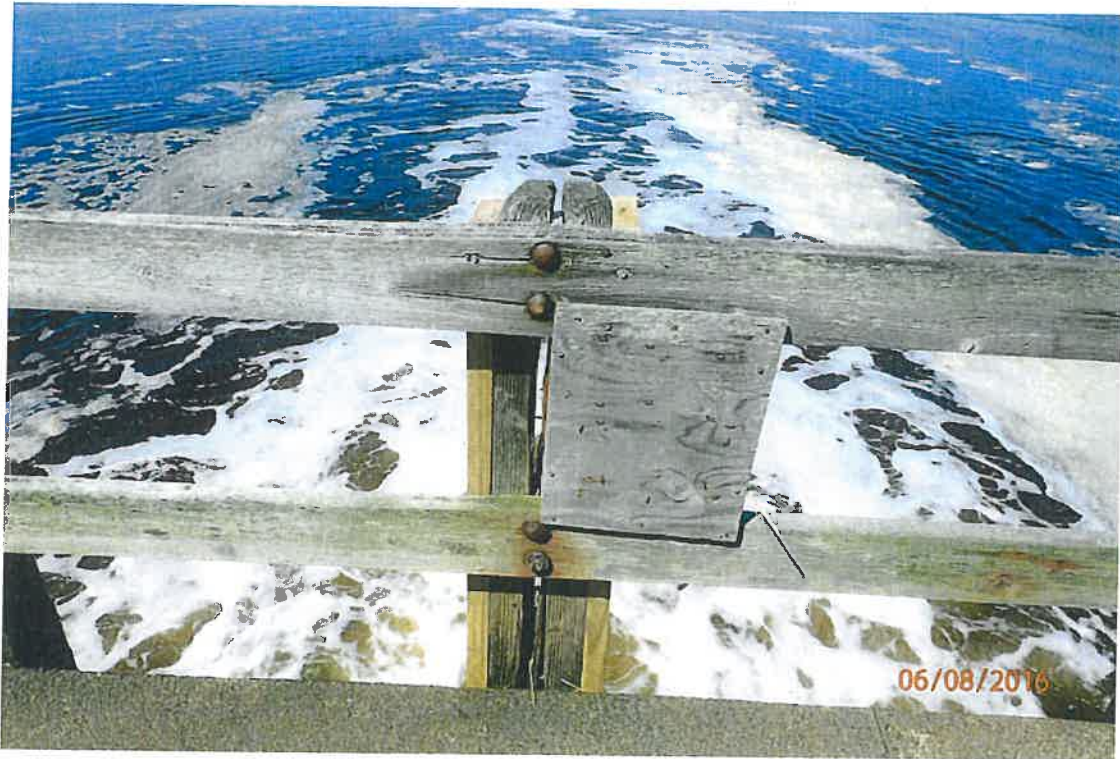
Photo 17: Center post at west has been shored.

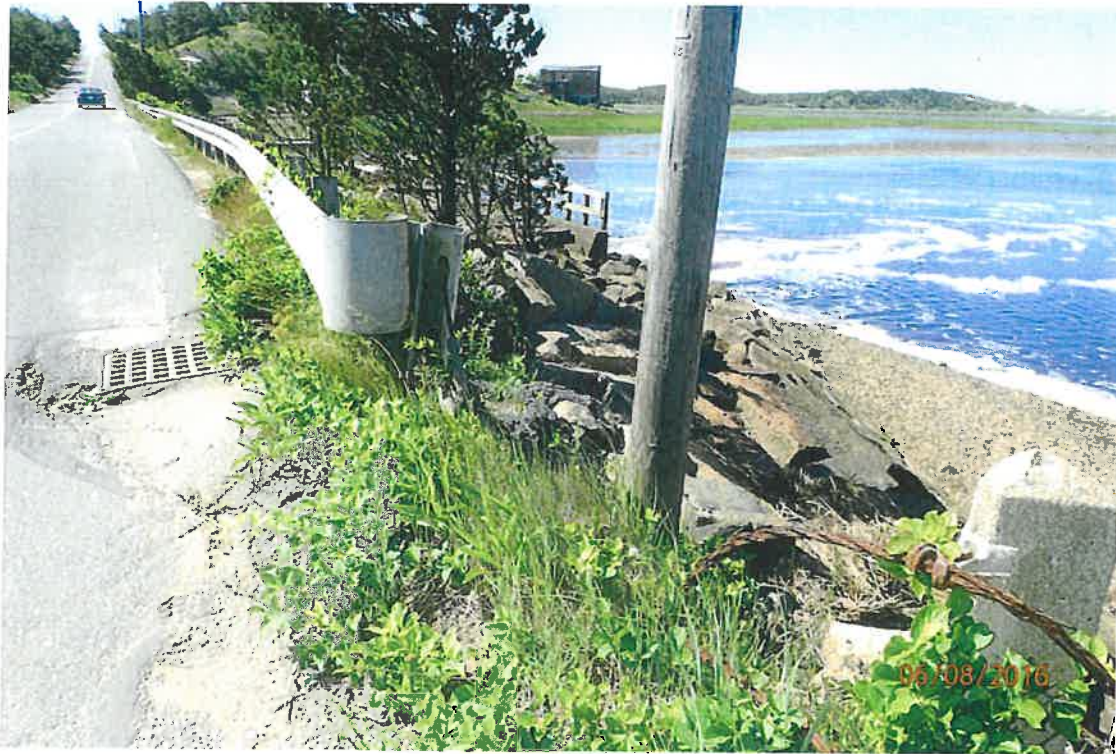
- Type-W guardrail carries from approach over bridge.
- Type W guardrail abruptly changes to non-standard cable & post railing.
- NW W-shape end is cantilever 6+ ft presenting a potential impalement condition, photos 21 & 22. This condition is hidden by a post at the end, part of the failed disconnected nonstandard cable system of which the 5th post at the NW is broken.
- SE cable is covered with sand.
- NE cable is only 18" above the berm, the lower cable is loose, and the 3rd post from bridge has exposed rebar.
- Many posts have rusting rebar and cracks.
- Cables are rusty.

Photo 21: NW gloved end is detached from post.

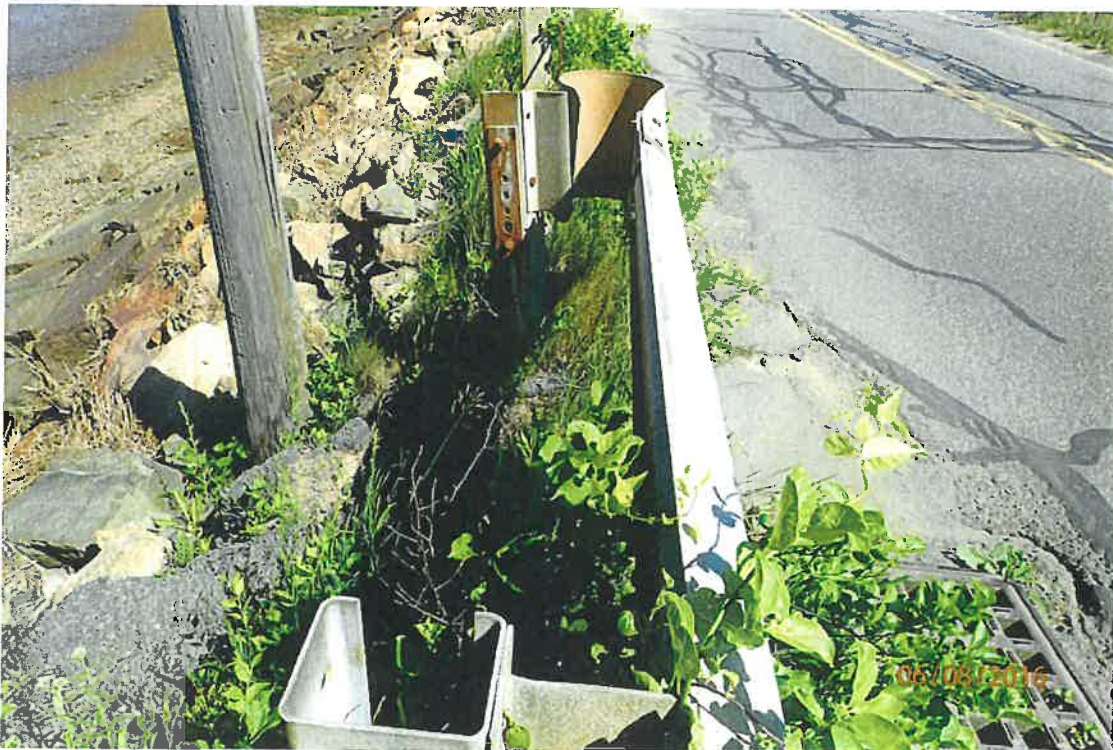
Photo 22: NW gloved end and first section of rail is cantilevered (not connected at end).

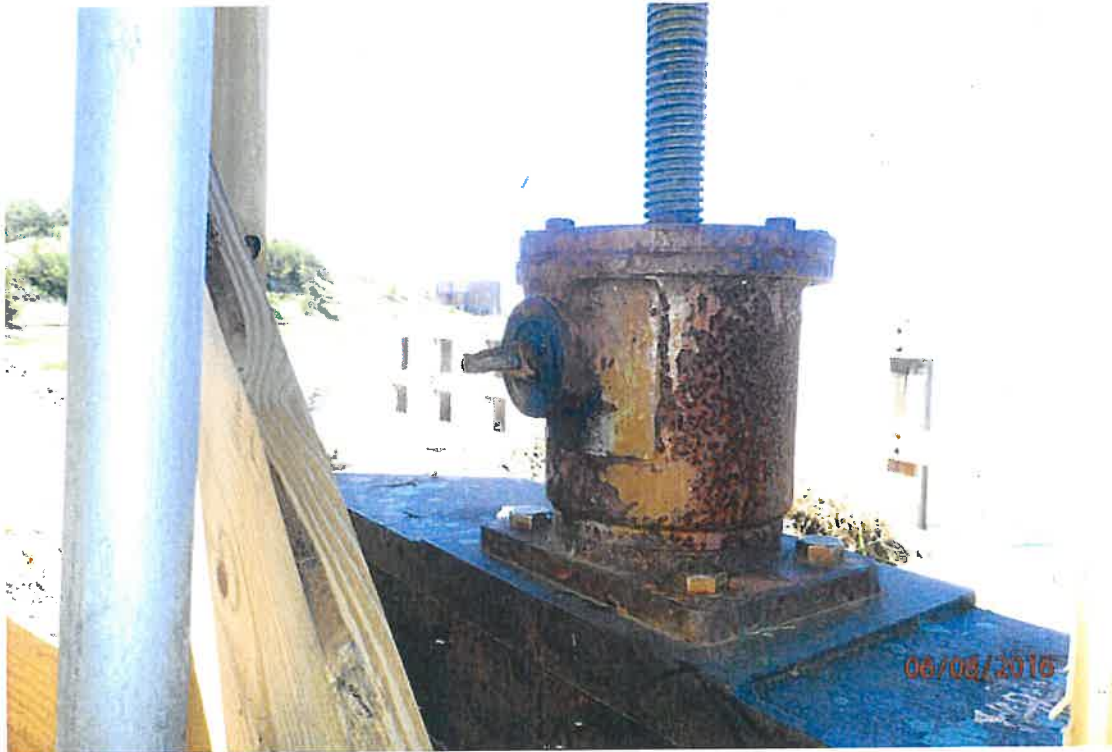
- The center and north barrels each have a directional control flapper gate that allows flow toward the downstream end (west).
- The south barrel had an adjustable bidirectional flow control gate that appears to be inoperable due to a severely corroded crank receptacle and a new building built for the U.S Government for water quality control on the west embankment, that is immediately in front of the mechanism, photos 19, 23 & 24.
- An intake pipe has been installed between the center and the south barrel, photos 5 & 20.
- Photos 1, 2, 5-11 are of items in the dive report. Please refer to Routine Underwater Inspection June 8, 2016.

Photo 23: SW gate control mechanism appears to be non-functional.
