Town of WellFleet

STRUCTRES INSPECTION / EVALUATION REPORT

Tide Gates at Chequesset Neck Road over Herring River

Structure Number: W-14-007

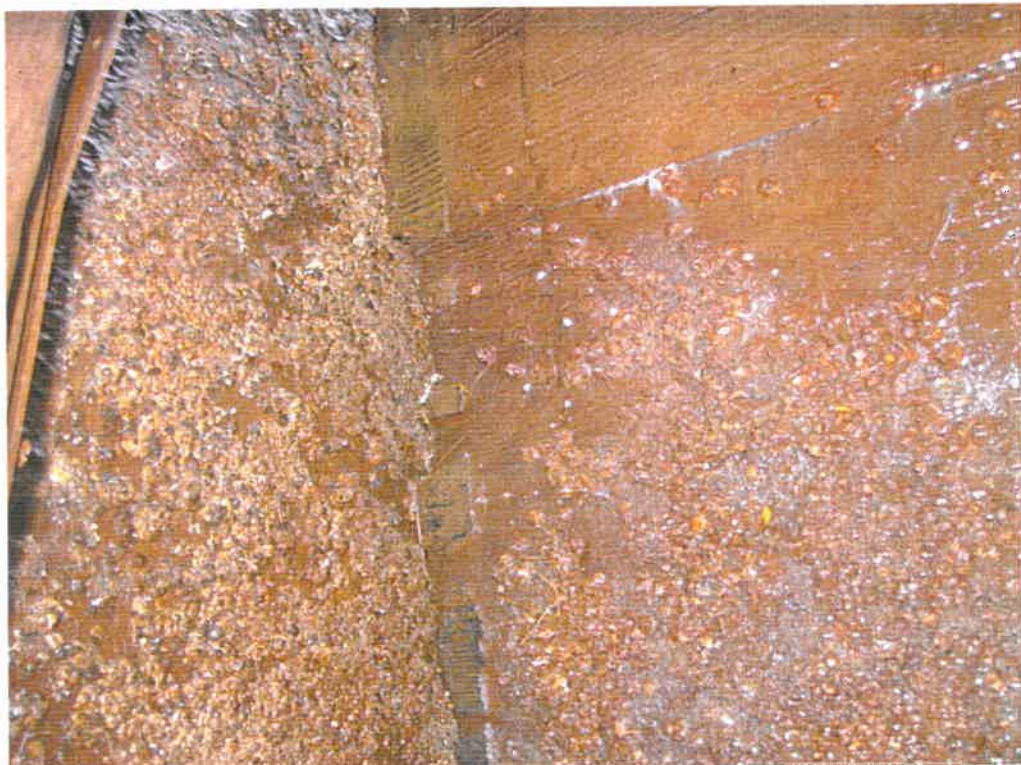
The inspection results of the gate in the center barrel were similar to the north barrel. The timber appeared sound but exposure to the marine environment resulted in irregularities in the gate surface. The irregularities in the surface appear more acute towards the perimeter of the gate and the seating surface with the tee seal. The lifting hardware, eyebolts, could all be rotated by hand indicating potential shrinkage of the timber. Additionally, the center weight plate was loose indicating the back up nut was not adequately securing the plate to the threaded rod.

Figure 12: Deteriorated Tide Gate at Seating Surface South Edge Center Barrel

Due to the irregular surface of the tide gates, reuse of the existing gates would result in some level of inflow of water between the interface with the seal and gate. However, we also expect this inflow to be relatively minor. Perhaps the Town of Wellfleet would find this inflow acceptable. We suggest the Town of Wellfleet to consider a cost to benefit analysis prior to making this decision. We would also note that replacement of the gate at this time would more evenly match the life cycle of the gate with the other elements of the assembly. It should be noted that the mobilization and labor costs to remove and reinstall the gate would be incurred during the repair of the grout pads, frames and seals regardless if the gate is replaced. Therefore only the costs of the material and fabrication of the gate would be additional. Hence, it may be cost effective to replace the gate at this time as opposed to that in the future.

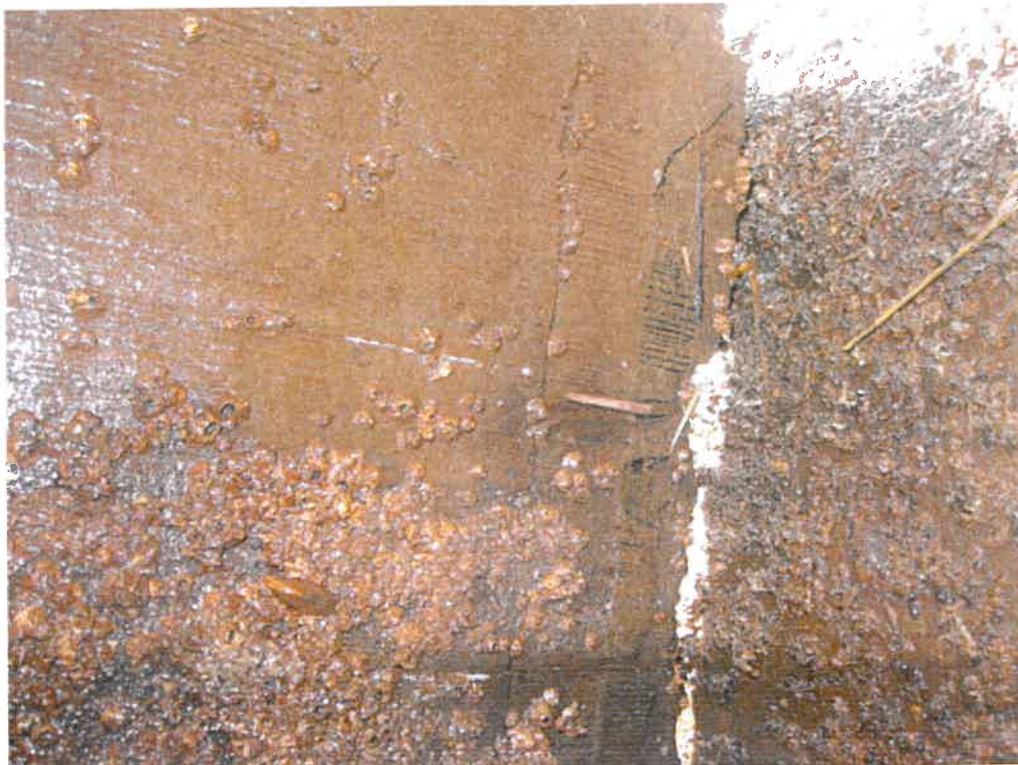
Figure 13: Deteriorated Tide Gate at Seating Surface North Edge Center Barrel

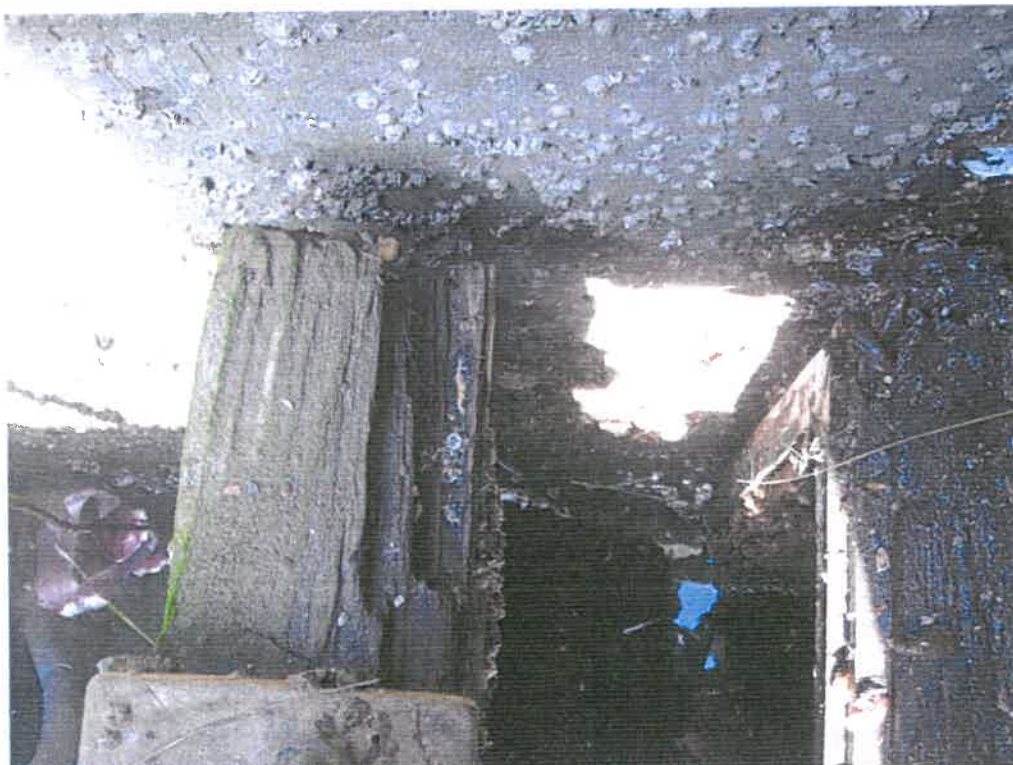
Inspection of the tide gate yielded a gate exposed to a marine environment. The timber of the gate appeared sound based upon probing the surface with a putty knife. Significant irregularity of the timber surface, particularly at the seating surfaces at the perimeter of the gates, was noted. The lack of marine growth at these surfaces indicates some contact is made with the tee seal. However, the irregular surface is suspected to be a source of water infiltration between the gate and tee seal. Although, other irregularities were noted upon the surface of the gate it was not considered to contribute to the infiltration of water through the gate. Eye bolts could not be rotated by hand and the weight plates appeared securely fastened.

Figure 14: Deteriorated Tide Gate at Timber Frame Header

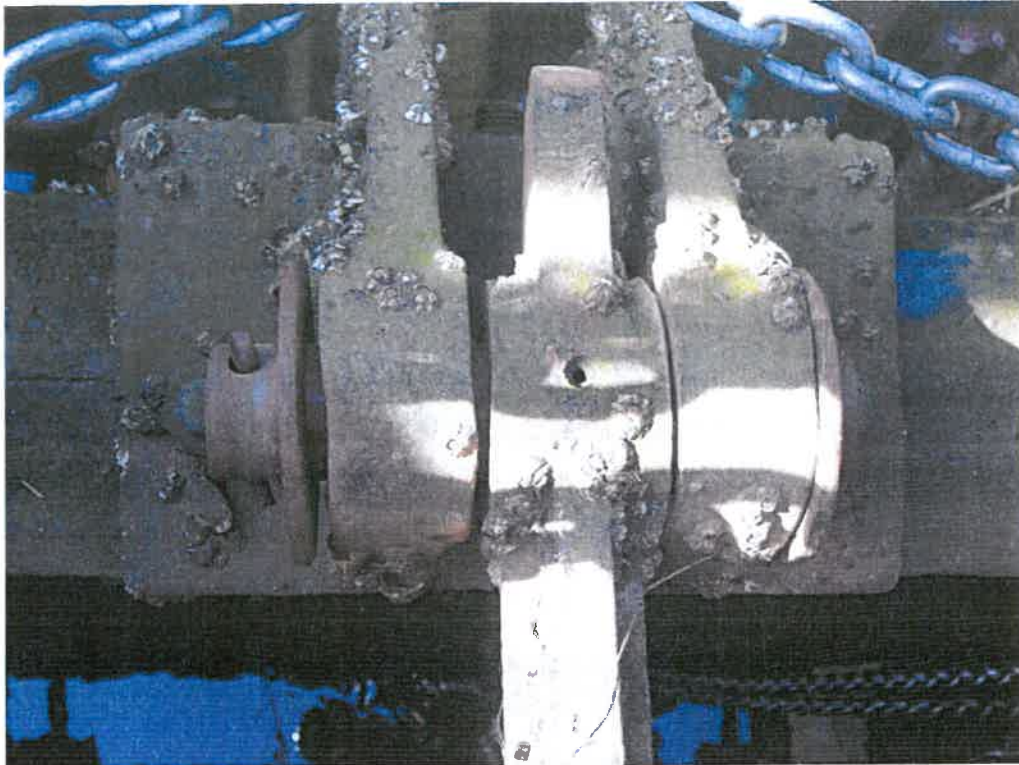
Wear in all hinge assemblies result in a fair assessment for this component. The lack of bushings and resultant wear on the assemblies result in misalignment of both tide gates. However, it is uncertain to the contribution of this misalignment to the total infiltration of water around the tide gate assemblies. Since the lack of marine growth at the seating surface, along the vertical sides and header, indicates the gate is making contact with the frame. The minor deterioration of the grout pads at the hinge supports to the structure are not considered to adversely affect the operation of the tide gates. Hence, remedial repairs to the grout pads are not considered necessary at this time.

Figure 15: Typical Worn Hinge Assembly with Missing Bushings

Replacement of the bushing at the hinge assemblies as recommended to improve the alignment of the tide gates. Replacement of the bushing may not solve the misalignment due to wear in its entirety. However, it is uncertain as to the contribution of the misalignment to the inflow although we suspect it is minimal if at all. Hence, we do not recommend replacement of the hinge assemblies.

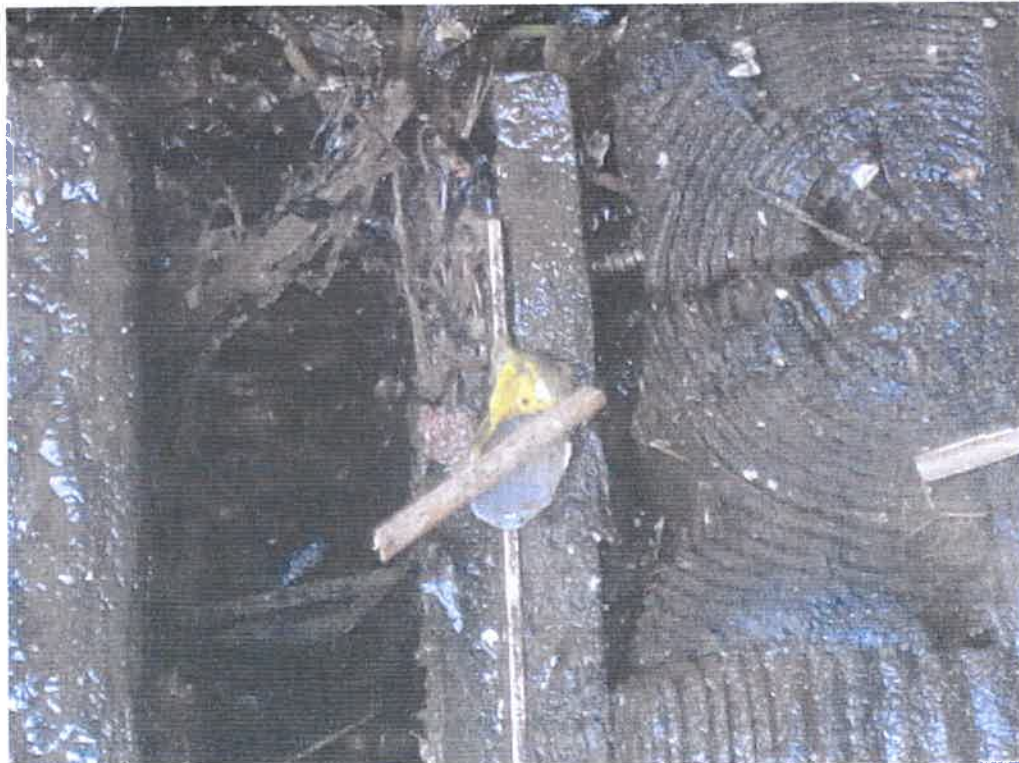
Figure 16: Tee Seal Assembly at Header Center Barrel

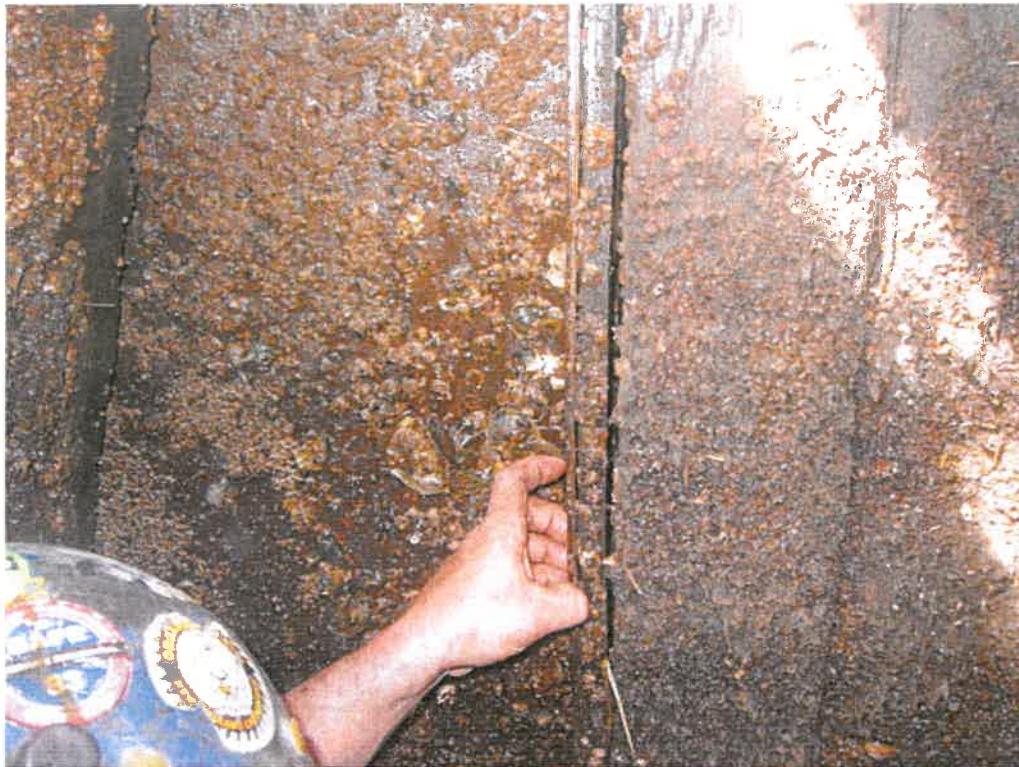
Figure 17: Tee Seal Assembly at Timber Frame North Vertical Center Barrel

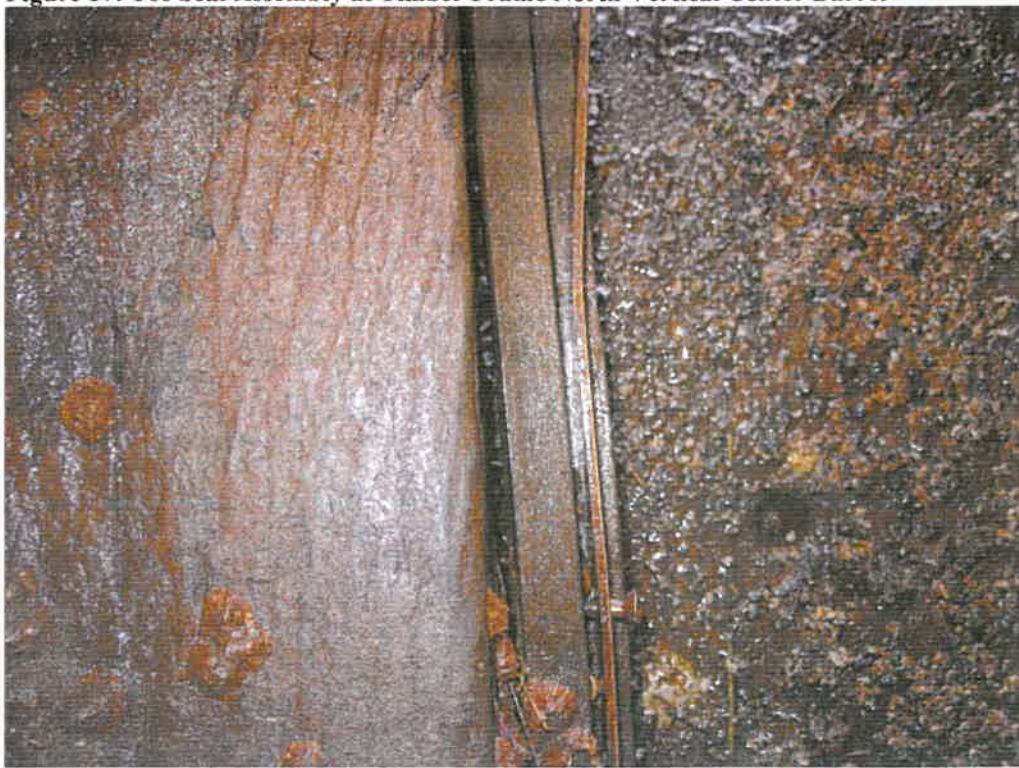
The tee seal assembly is considered in poor condition as a unit. Although the neoprene itself is in relatively good condition, the fasteners and fastening plates are failing to adequately secure the seal to the substrate. This condition is expected to allow water to infiltrate between the seal and frame. However, the lack of the seal at the invert slab of the North barrel is considered to result in a significant inflow of seawater past the closed tide gate assembly. Similarly the seal along invert slab of the Center barrel is not considered to seat properly allowing water to infiltrate when the tide gate is also closed.

Figure 18: Tee Seal Assembly (inadequate seating and fastening to substrate)

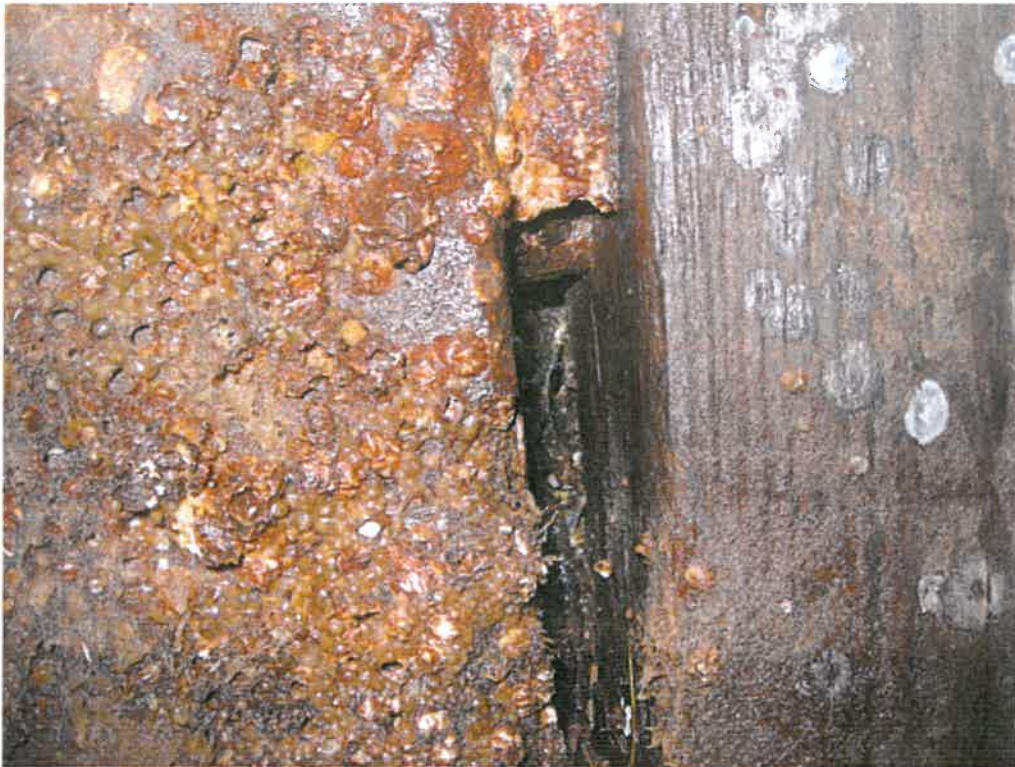
Visual observations of the grout pad along the vertical interface of the frame and water control structure wall yielded locations where the grout was missing, up to approximately 12" in some locations. Further visual observations of the grout along the header yielded it appeared intact. Further probing with a putty knife along the header indicated the grout was intact and generally sound. However, probing along the vertical interface yielded areas where the grout could be dislodged with little effort and generally considered unsound. Further probing between the invert slab and frame indicated large areas of grout were missing or otherwise considered unsound.

Figure 19: Missing Grout North Barrel South Vertical

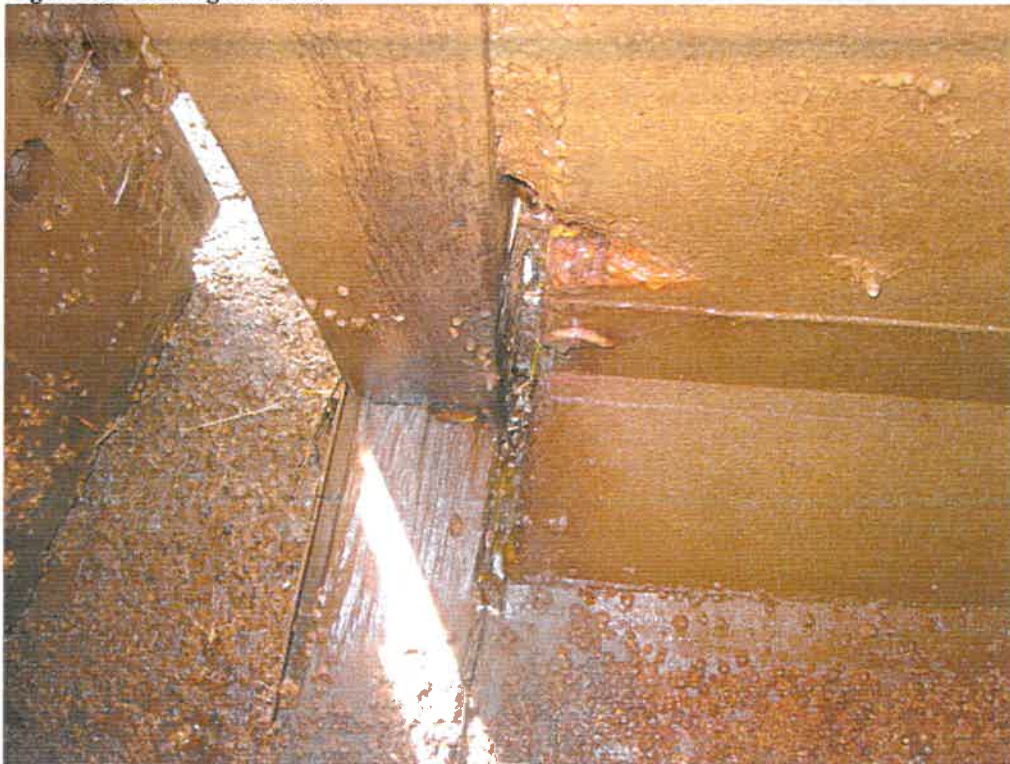
Removal of marine growth along the header of the frame indicated grout was missing up to approximately 6" and 12" from the north and south end of the header respectively. Inspection from within the center barrel yielded daylight through the grout pad between the water control structure and frame at these locations. Further probing along the vertical grout pads of both walls indicated severely deteriorated grout within 1'-0" of the interface with the roof and invert slabs. Probing the remaining locations along this interface yielded fair to sound grout. Probing the grout pad along the invert slab yielded the grout was non-detected along the entire length.

Figure 20: Missing Grout Center Cell at Roof Slab North (note: Spall at Roof Slab)

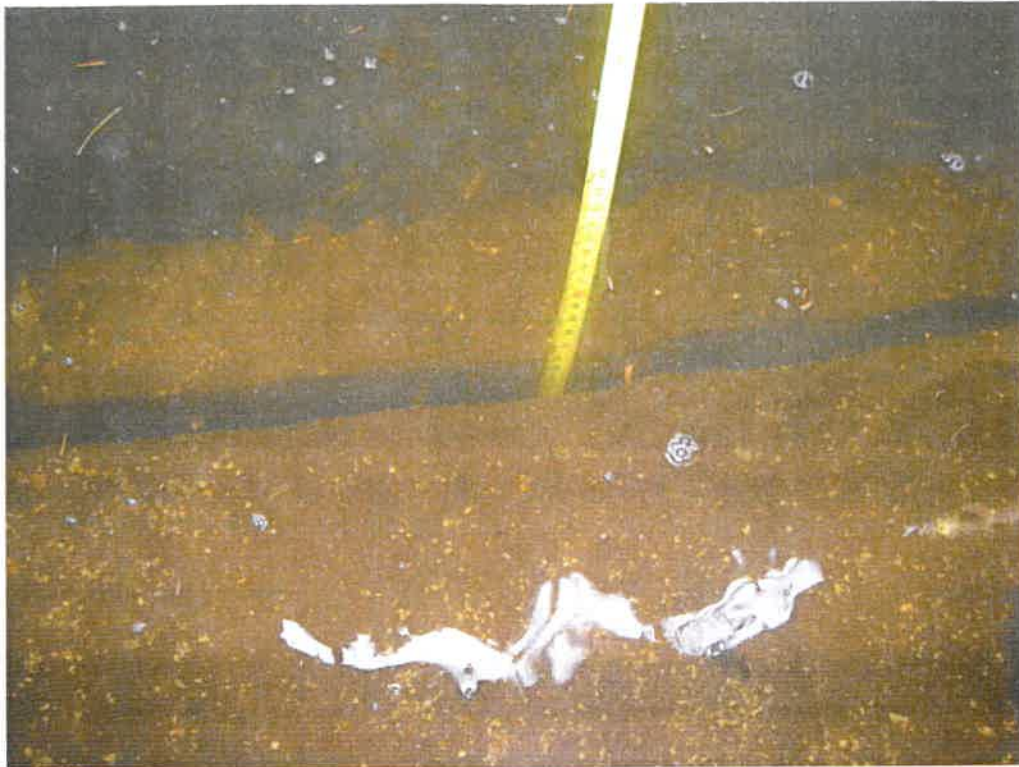
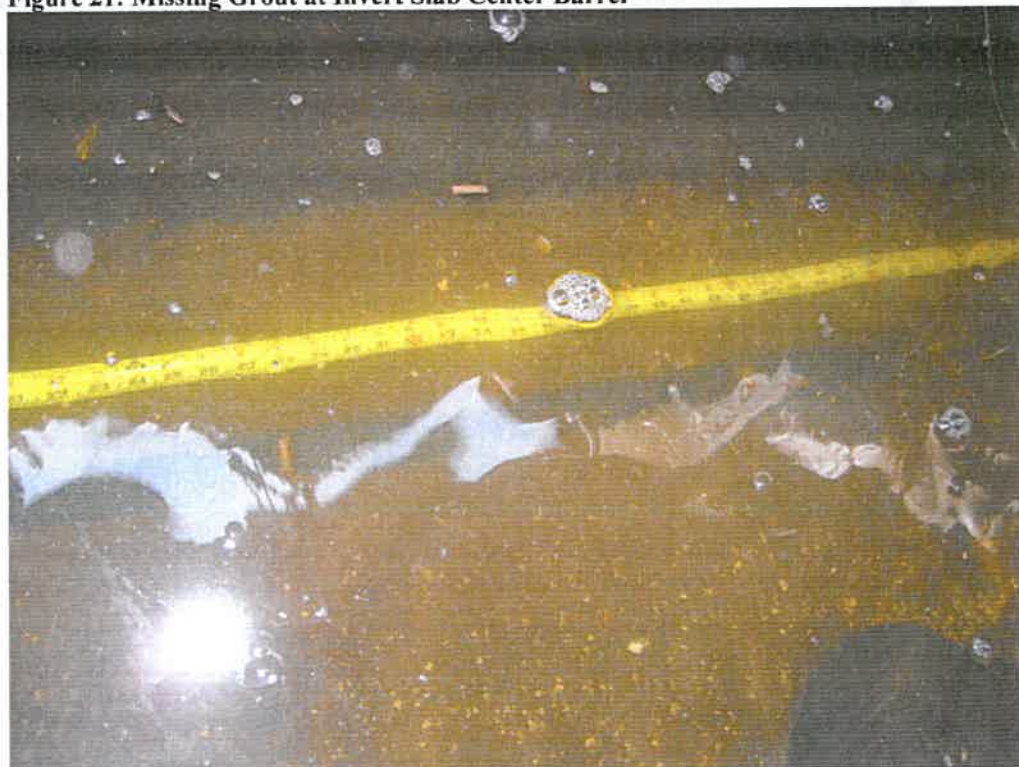
The grout pads are considered in poor condition due to the significant amount of grout missing. The lack of grout along the invert slab of both barrels is considered to significantly contribute to the amount of inflow past the tide gate assembly. Additionally, the missing grout from the vertical and header sides of the frame for the North and Center barrels respectively also results in a source of inflow.

Figure 21: Missing Grout at Invert Slab Center Barrel

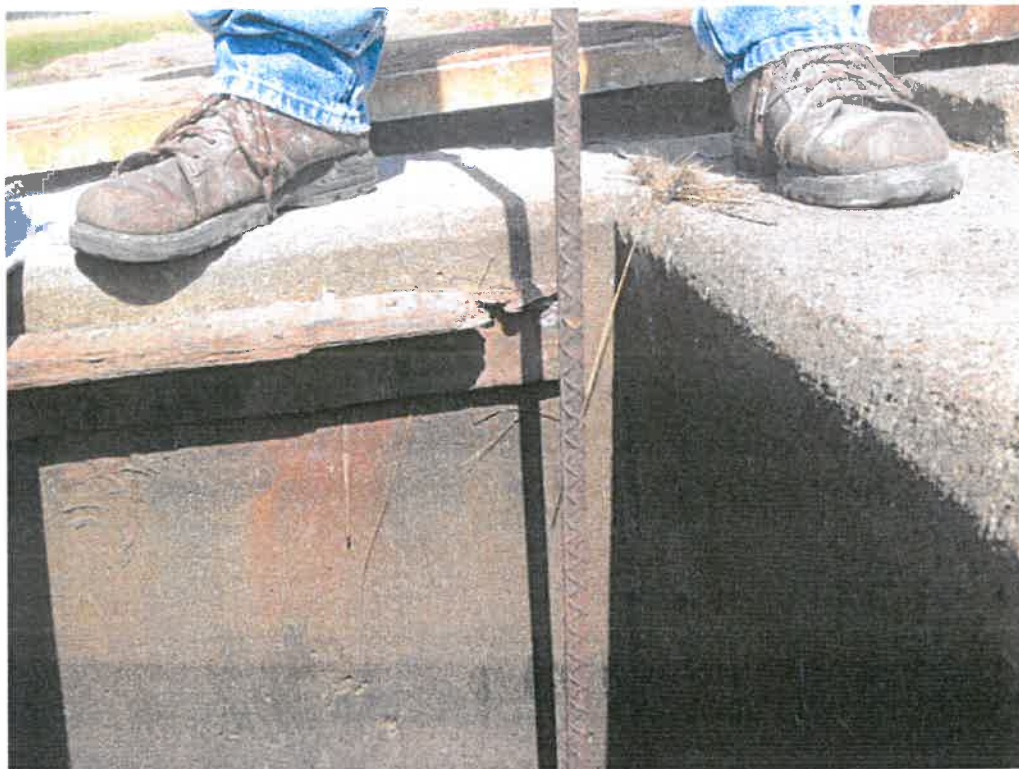
Access to the tide gates and associated assembly was accomplished by removal of the steel grating over the tide gates. Removal of the grating yielded L3x3 angles supporting the grating exhibiting advanced deterioration due to exposure to marine environment. During modification of the support angles to allow for stop log installation, the advanced deterioration of the angles supporting the grating was observed. The grating also exhibited deterioration due to exposure to the aggressive marine environment. The grating was only removed over the gates North and Center barrels. However, the condition of the grating and support at the South barrel is considered similar. The grating over the North and Center barrels along the Herring River did not show as advanced deterioration. However, it would be expected that the condition of this assembly will advance to a similar condition as the harbor side with time.

Figure 23: Advanced Structural Distress Grating Support

- Remedial repair design, fabrication and replacement of grating supports
- Remedial repair design, fabrication and replacement of grating

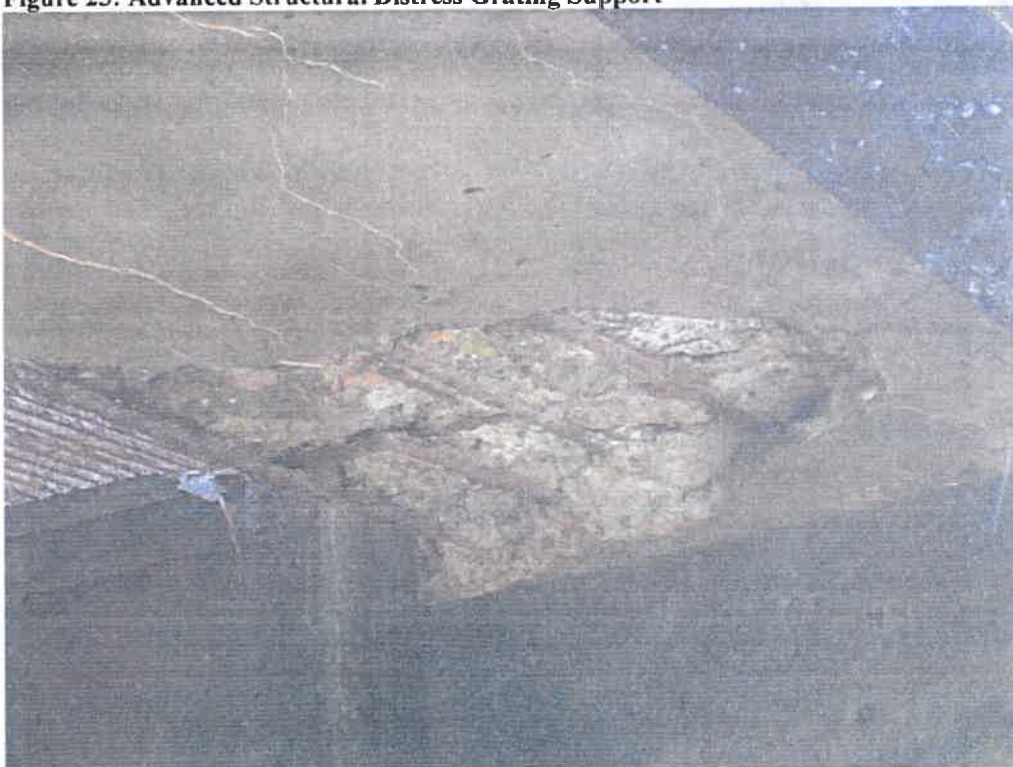
The deck slab spanning the North barrel flume downstream of the tide gate exhibited significant spalling. Over 3" of concrete, out a total slab thickness of 9", over an approximately 4' x 3' area had spalled exposing the bottom reinforcement. The exposed reinforcement exhibited advanced section loss with some bars completely deteriorated. A smaller spall was also noted at the headwall.

Figure 24: Deck Slab Spall over North Barrel Flume

CEI also recommends action be taken to remediate the life safety issues noted during our inspection. Repairs to the grating and grating supports over the flume of all three barrels and the roof slab over the North barrel flume at the harbor side of the water control structure should be prioritized within the Town's maintenance program. Our observations of the grating and grating

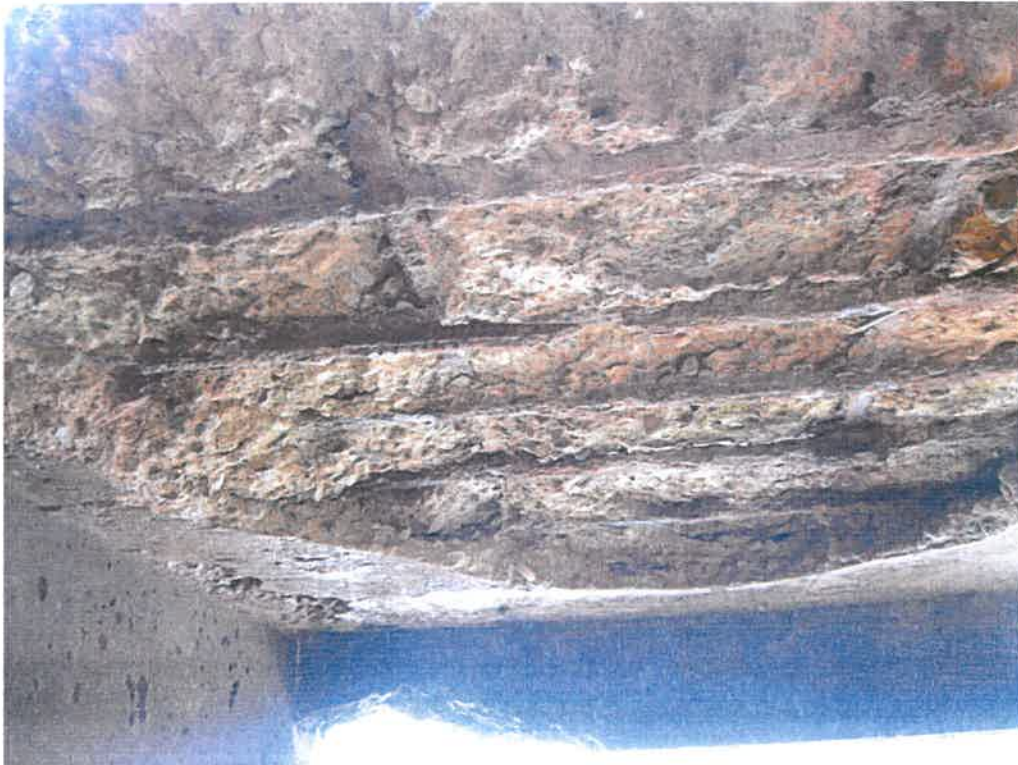
Figure 25: Advanced Deterioration of Reinforcement at Deck Slab Spall over Flume

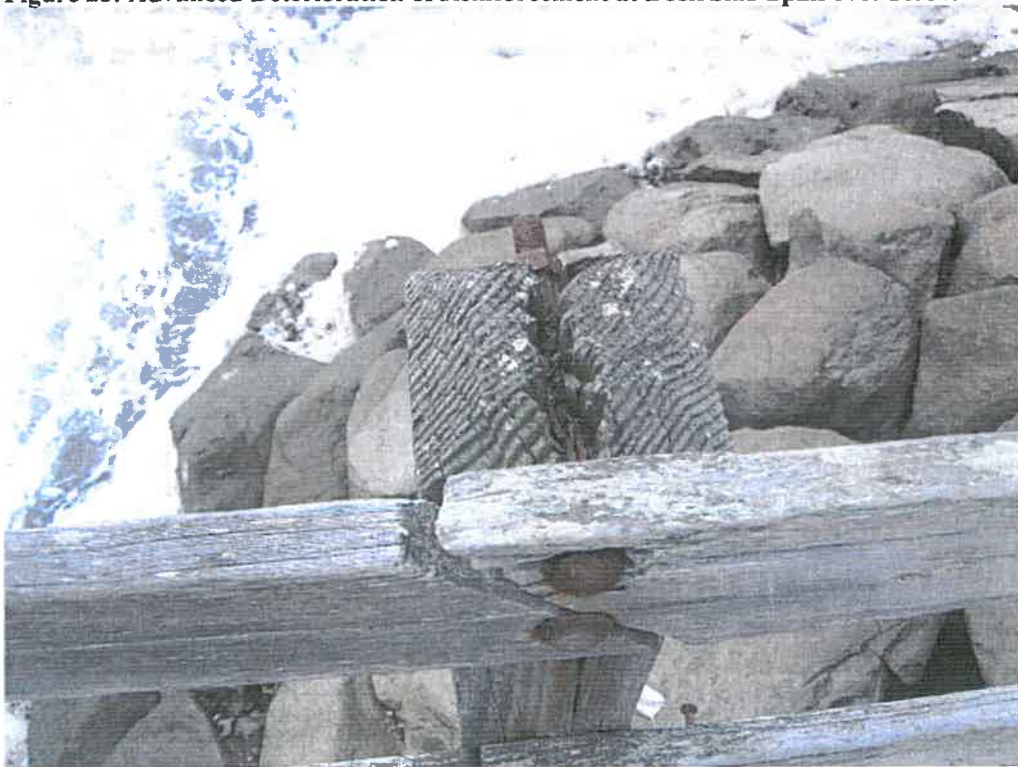
The railings and posts at both ends of the water control structure exhibit signs of structural distress, including checking and splitting due to impact rust. The anchor bolts appear intact and reasonable condition although some of the securing nuts are missing.

Figure 26: Typical Safety Railing and Post

- Remedial repair design, fabrication and replacement of safety railings and posts

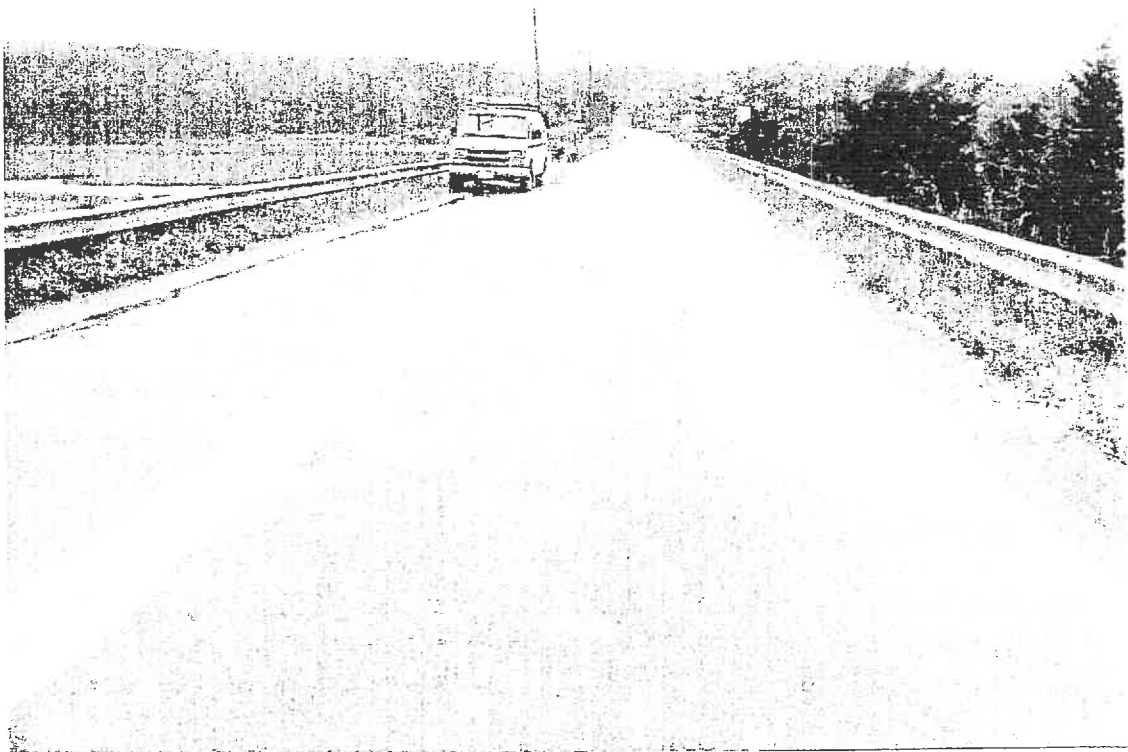
Minor cracks in the bit. concrete, some full width transverse, some longitudinal, and some map cracks. Most have been sealed. (Photo 6)

Photo 6: Wearing Surface

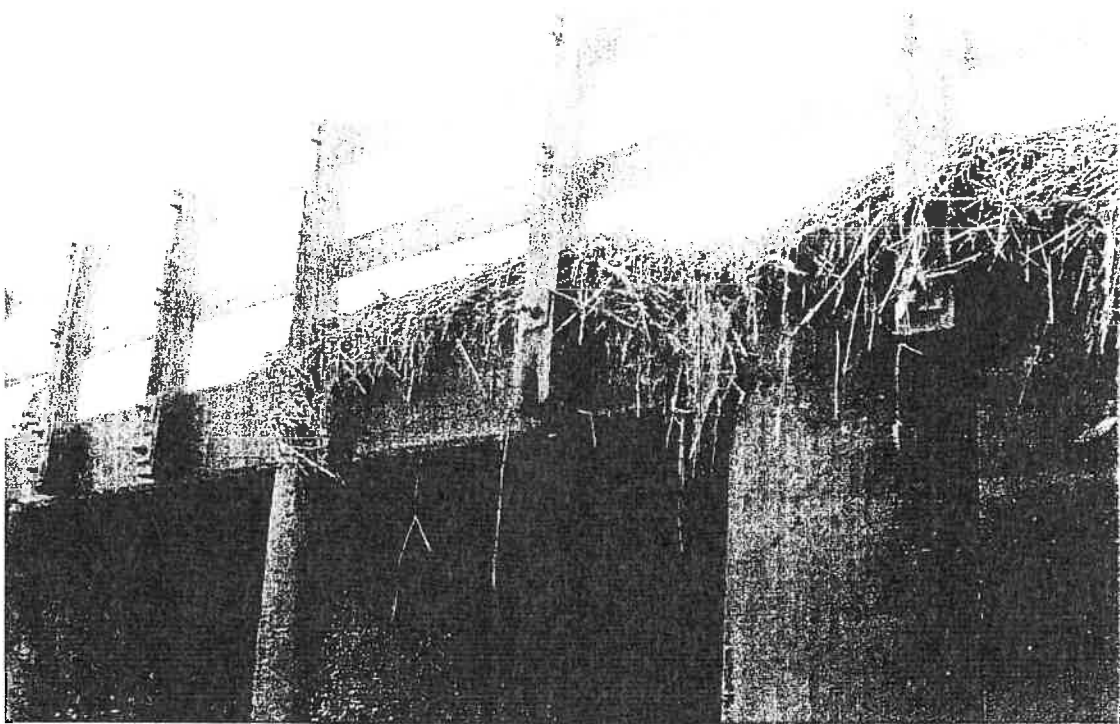
Photo 7: Railing post missing bolt - west side over south barrel.

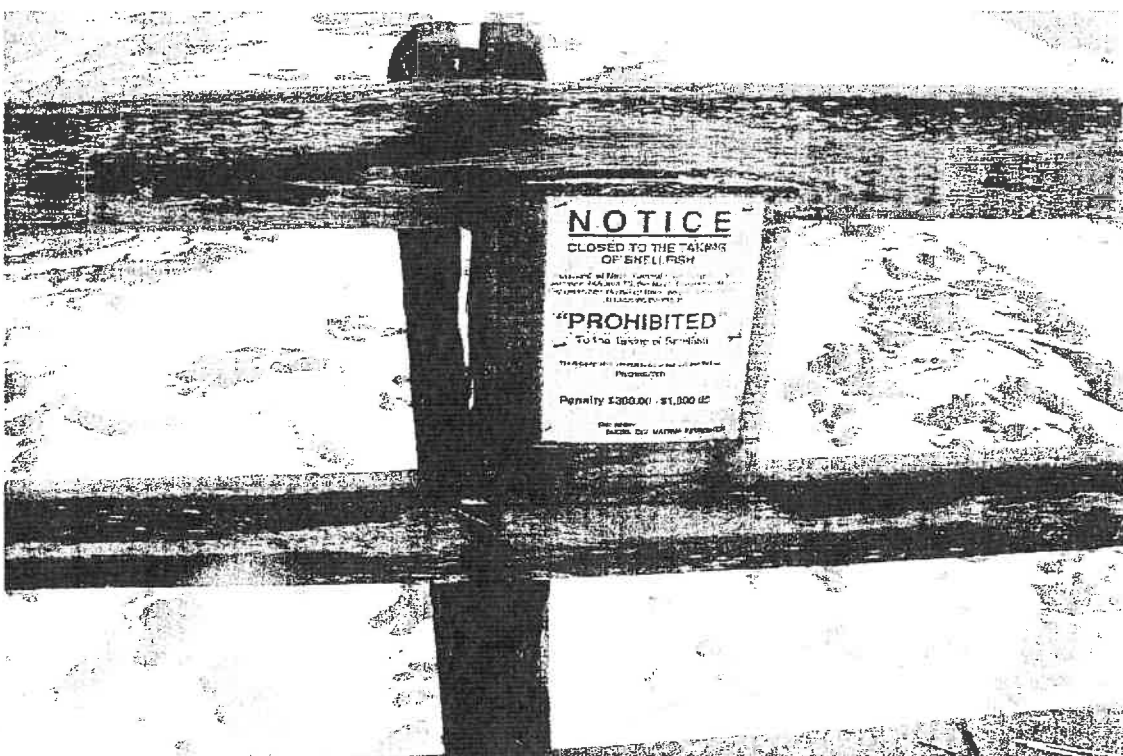
Photo 8: All railing posts are split (this one full hieght) most likely to pack rust of mounting bolts

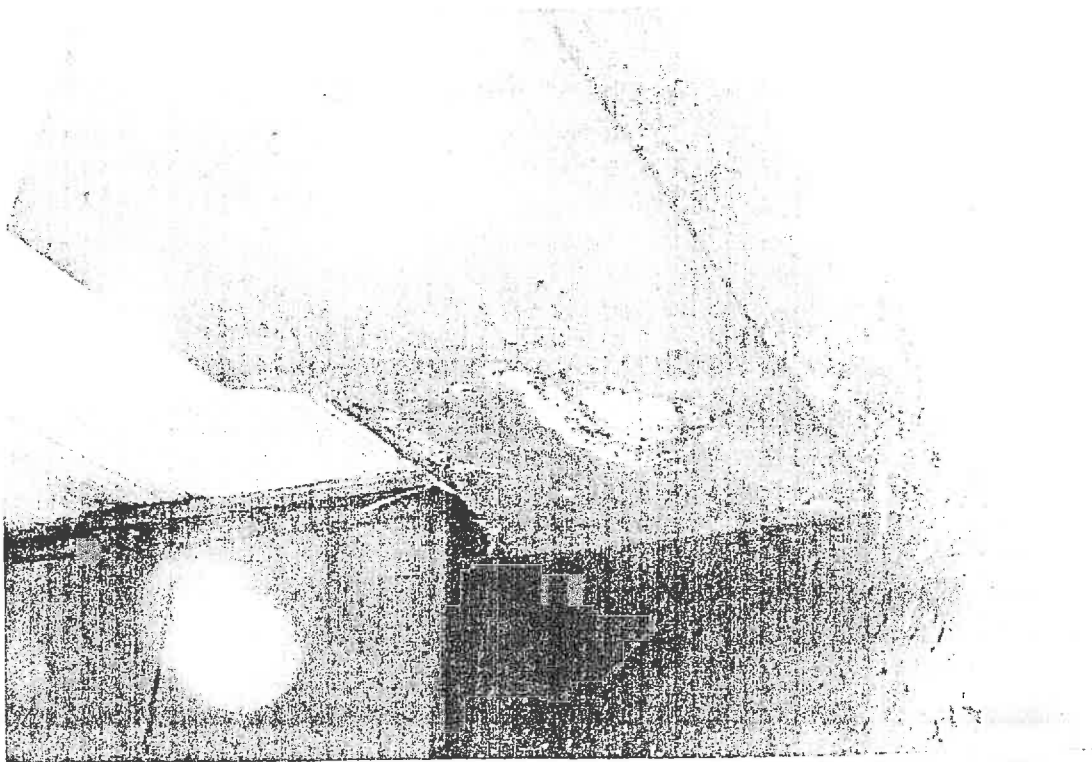
Photo 9: NW barrel roof spall and delamination exposed rebar.

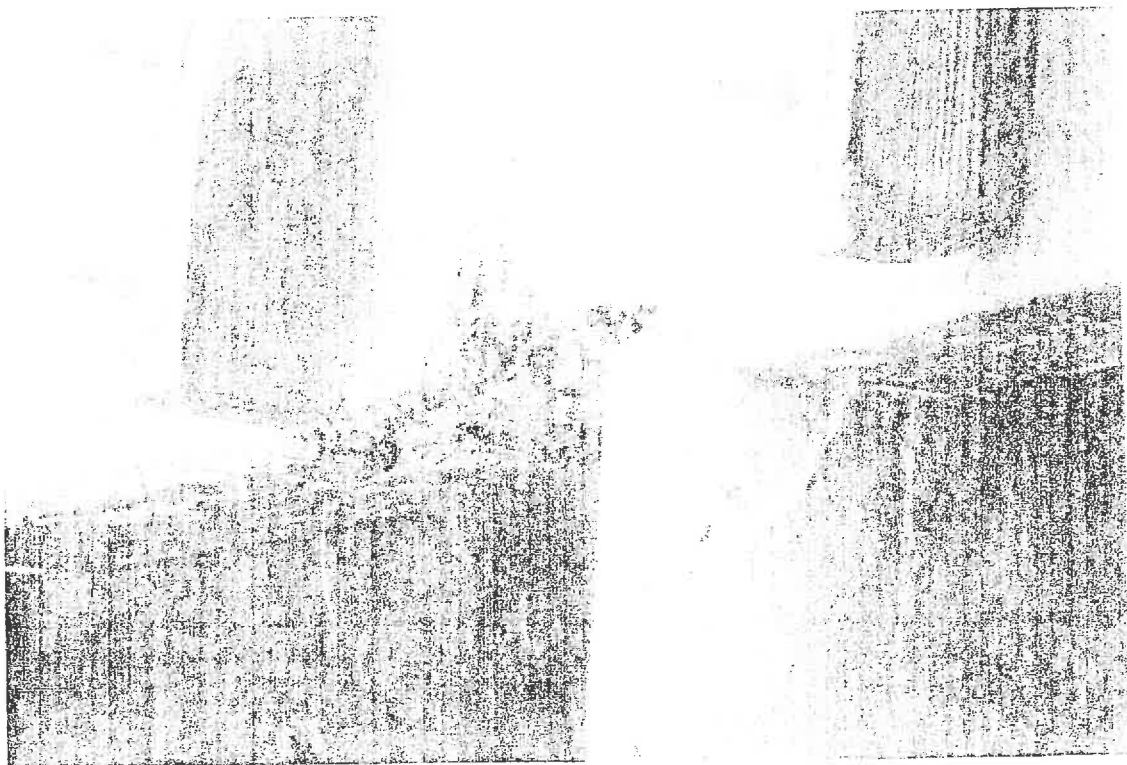
Previously reported spall in the west headwall at the north pier, 1.6' long by 8" wide by 3" deep. (Photo 10)

Photo 10: Spall over NW pier at headwall.

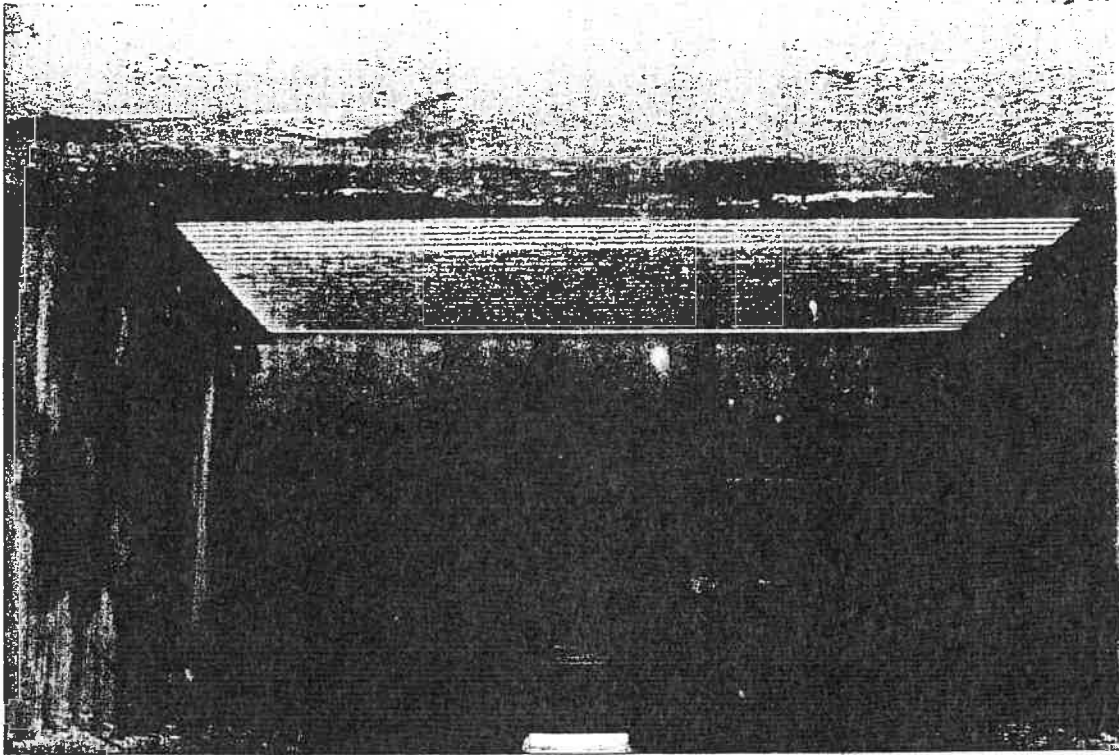
Photo 11: South barrel east end - roof with map cracking
