# Herring River Tidal Restoration Project

## *Conceptual Restoration Plan*

**Prepared and Submitted by:** The Herring River Technical Committee,  
with technical support provided by ENSR/AECOM, Inc.

*October 2007*

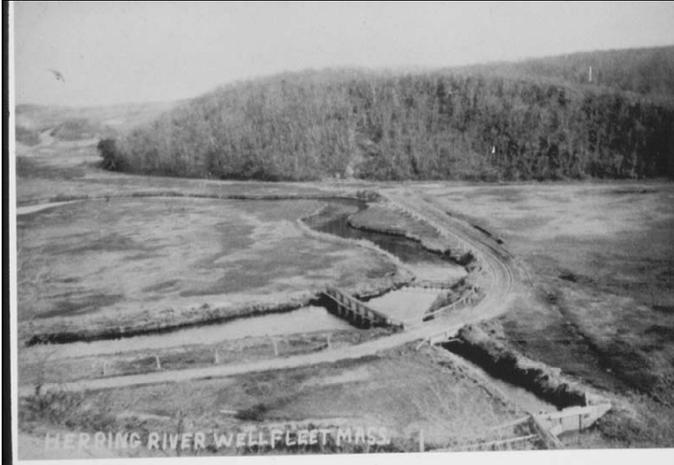
Photo 1: Since 1909, tidal exchange into Wellfleet's Herring River has been restricted by a dike fitted with three six-by-six foot culverts; two culverts are fitted with clapper valves to allow drainage but block the inflow of seawater; the third culvert has a partially open sluice gate that allows some seawater to flow into the river.

In 1909, the natural condition was changed dramatically when the mouth of the river was diked at Chequesset Neck (see Photo 1). The dike was constructed with the intent of controlling mosquitoes and creating arable and developable land. Subsequent ditching and stream channelization was intended to drain the system's wetlands even further.

The Herring River passes under Chequesset Neck Road through an earthen dike, which was constructed in 1909 and rebuilt in 1974. The dike contains three six-foot wide openings as part of a cast-in-place reinforced concrete box culvert. Two culverts are equipped with top-hinged timber flap gates and one is equipped with a vertical lift sluice gate. The flap gates open outward to allow discharge of water to Wellfleet Harbor, while the sluice gate allows bi-directional flow (see Photo 3). The most recent formal inspection of the dike by a professional engineer to assess its physical condition occurred on November 17, 2003 (MacBroom 2003). The inspection also addressed the structure's suitability for sustaining higher flow velocities if the gates were more fully open.

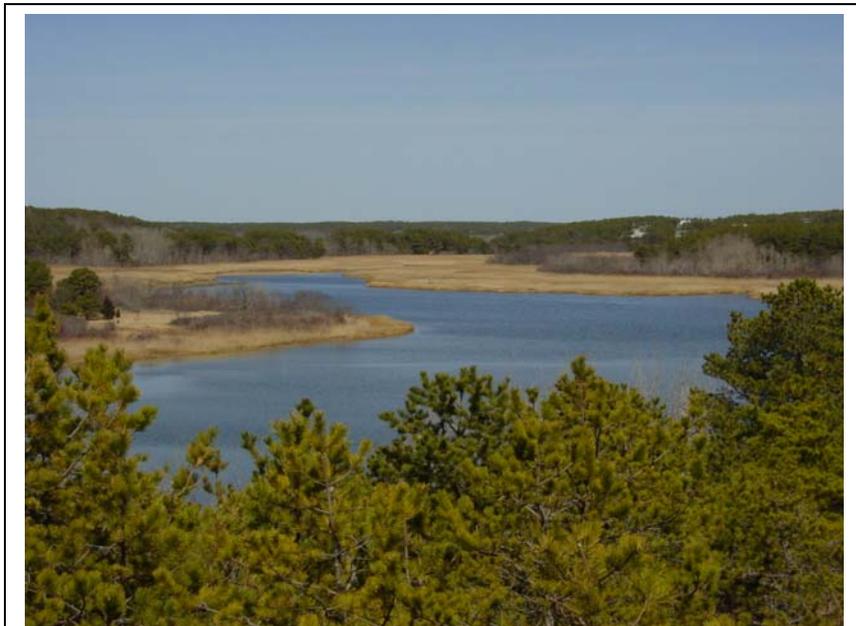
Photo 2: View of the lower basin of The Herring River just above Chequesset Neck.

The restoration will cause a major and extensive change in vegetation, with large areas presently covered by shrubs and trees reverting to saltmarsh grasses (see Photo 2). Plans are outlined to manage and monitor this process. Plans are also presented for monitoring and controlling mosquito populations. Finally, the CRP analyzes the effects of the restoration project on water quality and sediment transport in the downstream harbor, concluding that risks are low, but recommending targeted monitoring and management steps.

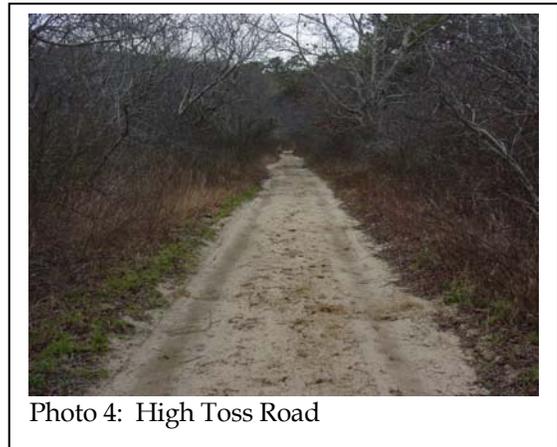
Photo 4: High Toss Road

High Toss Road crosses the Herring River approximately one mile upstream of the Chequeset Neck Road dike. This road (see Photo 4), is an unpaved, infrequently traveled, single-lane road that provides access from Pole Dike Road to Griffin Island. The road is only slightly higher than the adjacent wetlands. At the western end of the road, a tidally restrictive, 60-inch diameter, 24-foot long concrete culvert conveys the Herring River beneath the road.

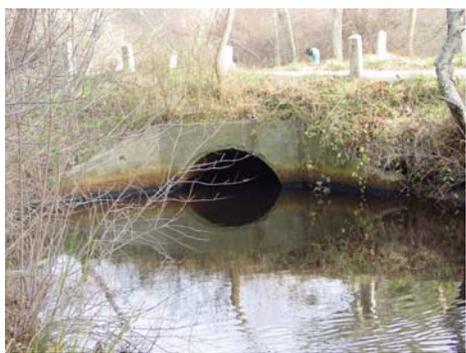
Photo 5: Bound Brook Island Road crossing the Herring River

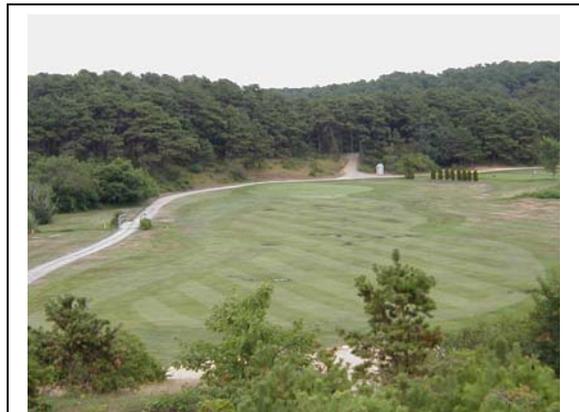
Photo 6: Low-lying portion of CYCC

The property currently occupies approximately 106 acres of land that abut a portion of the Wellfleet Harbor shoreline to the south, CCNS lands to the west and northwest, and private properties to the east and northeast. Land elevations on the property range from below mean sea level and approximately 60 feet. Despite a relatively large amount of upland habitat on the property, much of the golf course (portions of five of the nine fairways) was constructed at low elevations in the river floodplain adjacent to Mill Creek (see Photo 6). Despite diking of the floodplain, these lands have remained subject to saturated soil conditions, shallow inundation, and occasionally surface-water flooding due to heavy precipitation, seasonally high groundwater elevations, high-tide events in Herring River, and the presence of fine-textured soils (i.e. decomposed salt-marsh peat and marine clay). The CYCC contains both terrestrial and palustrine habitats including freshwater-dominant wetland areas, a portion of Mill Creek, man-made channels and impoundments, a very small saltmarsh area, and pitch pine-oak forest. A plan and environmental evaluation for course reconfiguration has

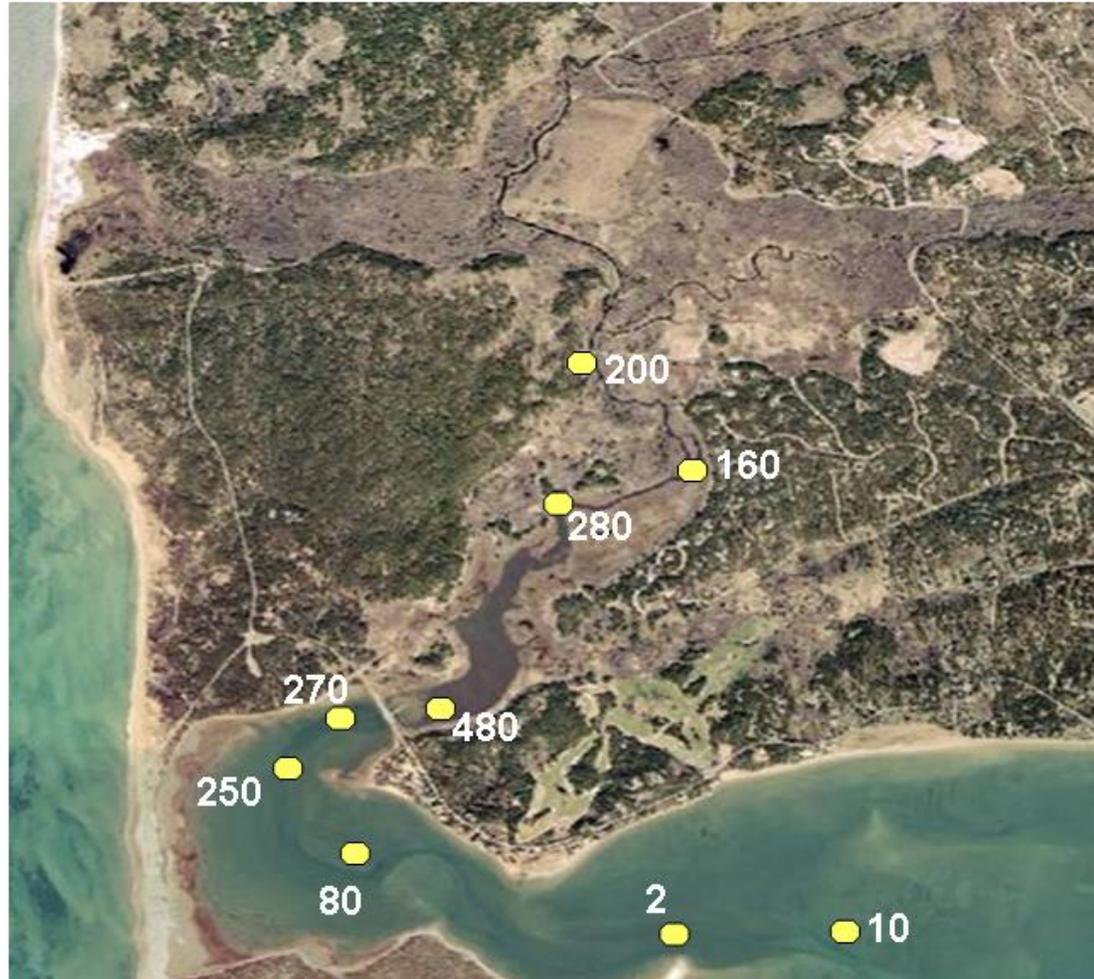
Figure 9. Fecal Coliform Concentrations in Herring River

Typical low-tide fecal coliform concentrations (colony-forming units per 100 ml) in Herring River. Fecal bacteria tend to accumulate around tidal restrictions because of poor tidal flushing, and low salinity increases bacteria survival time (Portnoy & Allen 2006). Shellfish harvest is prohibited if concentrations exceed 14 CFU/100 ml.

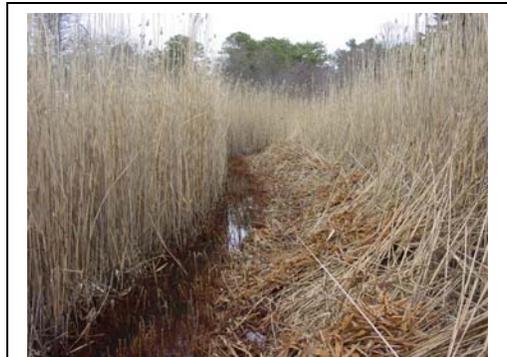
Photo 8: *Phragmites*-dominant marsh along Herring River

*Phragmites australis*, or common reed, occurs downstream of High Toss Road. *Phragmites* has some salt tolerance and therefore competes for space against freshwater wetland plants at moderate salinities, e.g. 10-20 ppt. When tidal flow was restricted, the river's salinity levels were greatly reduced, which allowed for *Phragmites* to invade places previously dominated by *Spartina alterniflora* and *S. patens* (see Photo 8). Besides the large monotypic stand just upstream of the dike, scattered small patches of *Phragmites* occur throughout the Herring River basin. Where this plant dominates close to the dike (within about 1,200 meters), small stands of *Spartina alterniflora* and *S. patens* occur at lower elevations adjacent to the river while a shrub zone, dominated by poison ivy (*Toxicodendron radicans*) and northern bayberry (*Myrica pensylvanica*) occurs slightly higher (Art 1981; Beskenis and Nuzzo 1984).

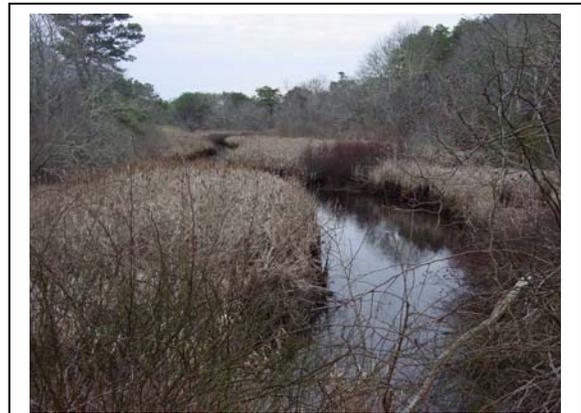
Photo 9: *Typha*-dominant marsh along Herring River

Cattail dominated (*Typha* spp.) communities tend to occur as the river loses more salinity. *Typha* is more indicative of fresh water and thus dominates the edges of the river, often along with *Phragmites*, as close as 1,200 m upstream of the dike (see Photo 9).

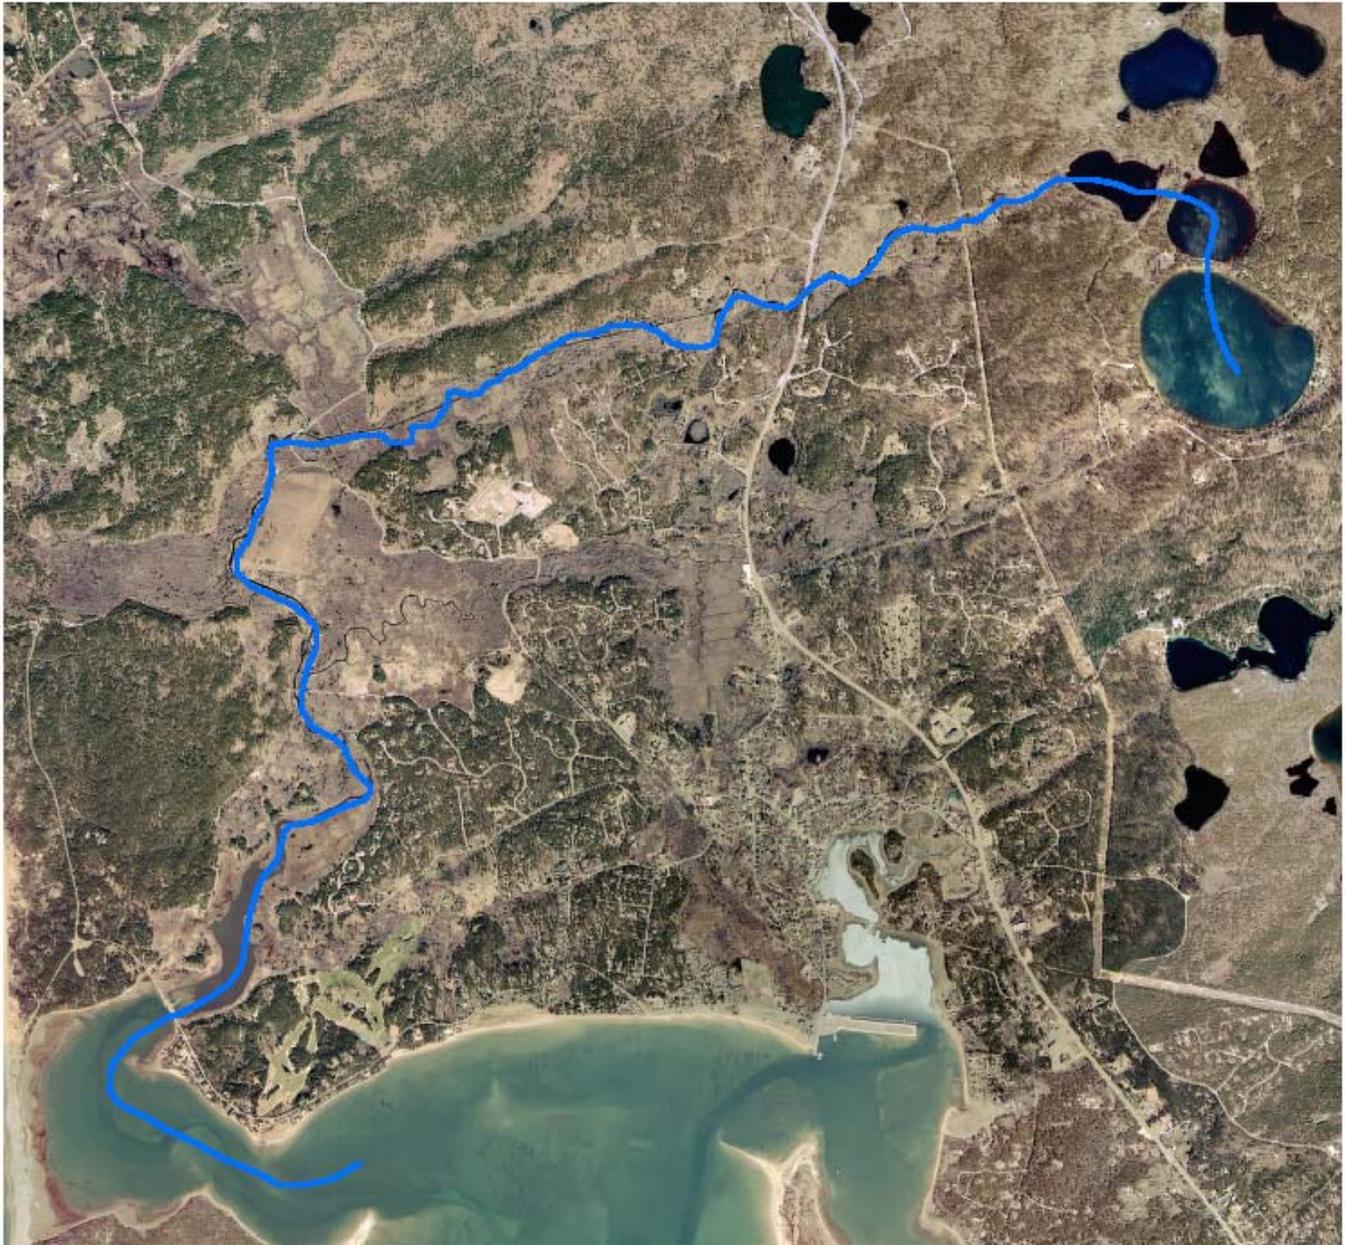
# Figure 12. Herring River Anadromous Fish Run

## Herring River, Wellfleet, MA Anadromous Fish Run

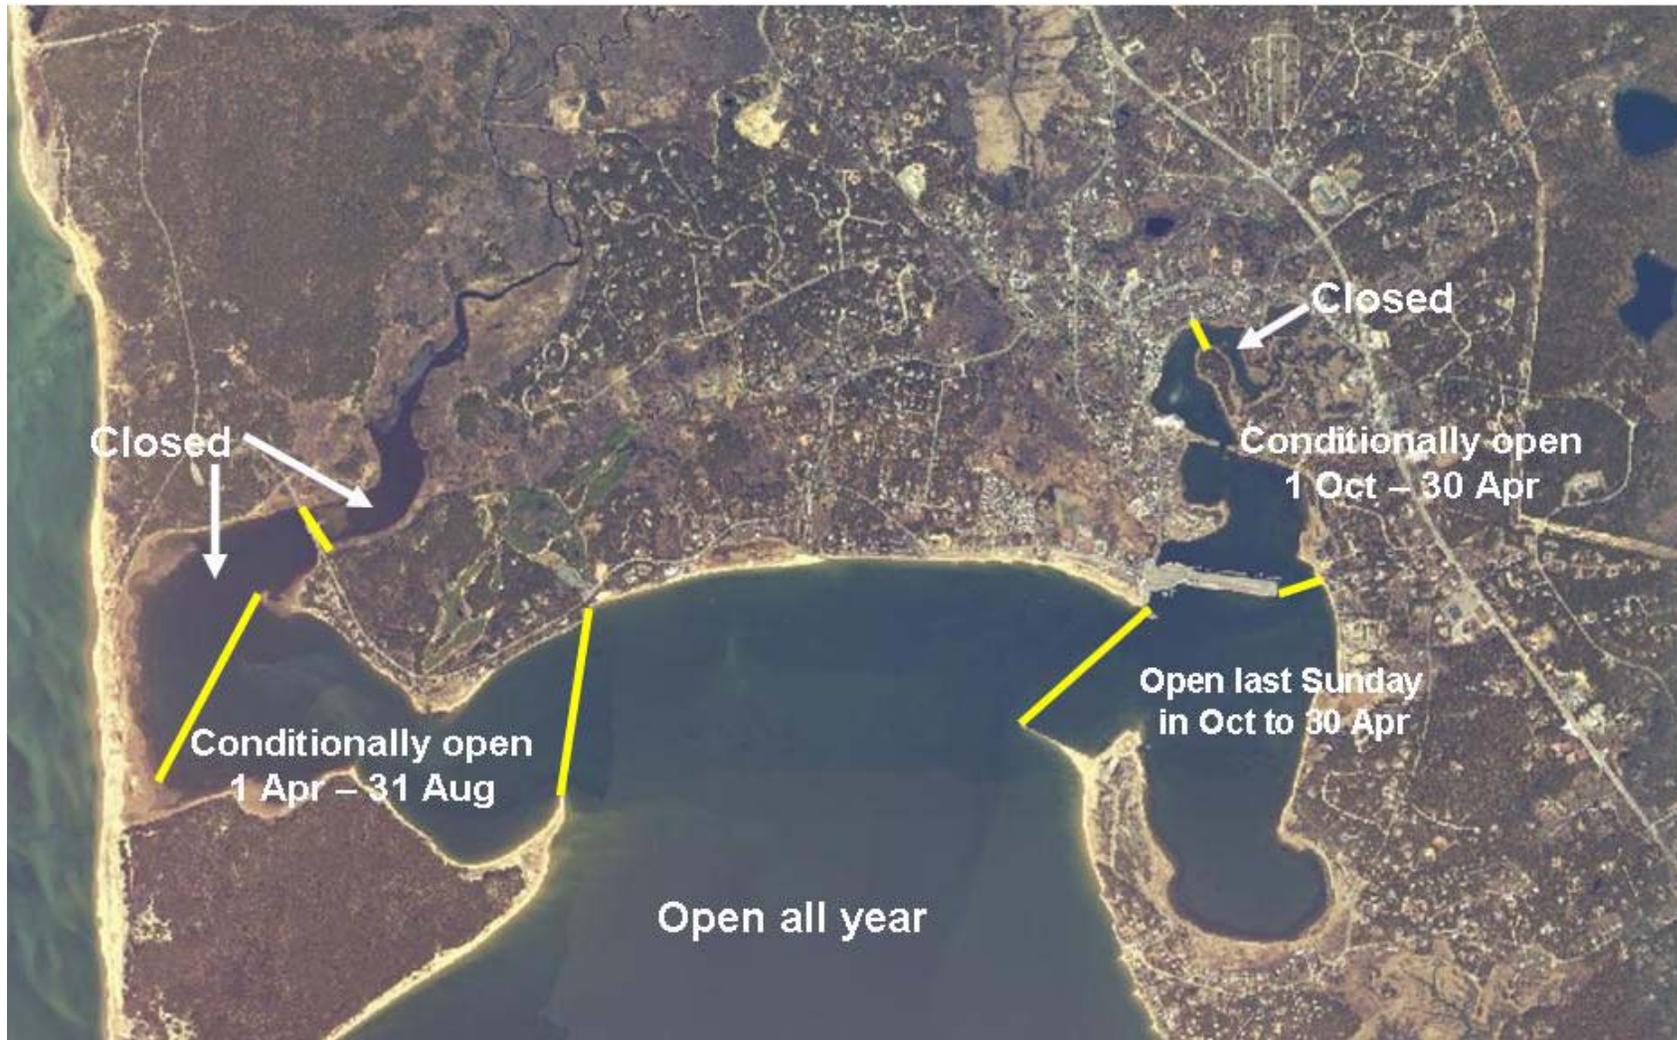
Figure 13. Designated Shellfish Closure Areas

Status of shellfish closures in Wellfleet Harbor including Herring River, fall 2007. State coliform sampling determines whether shellfish beds are open to harvest in “conditionally open” areas; typically these areas are closed for several days after major rain events. The waters just above and below the Herring River dike have been closed to shellfishing due to observations of high fecal coliform since the mid-1980s.

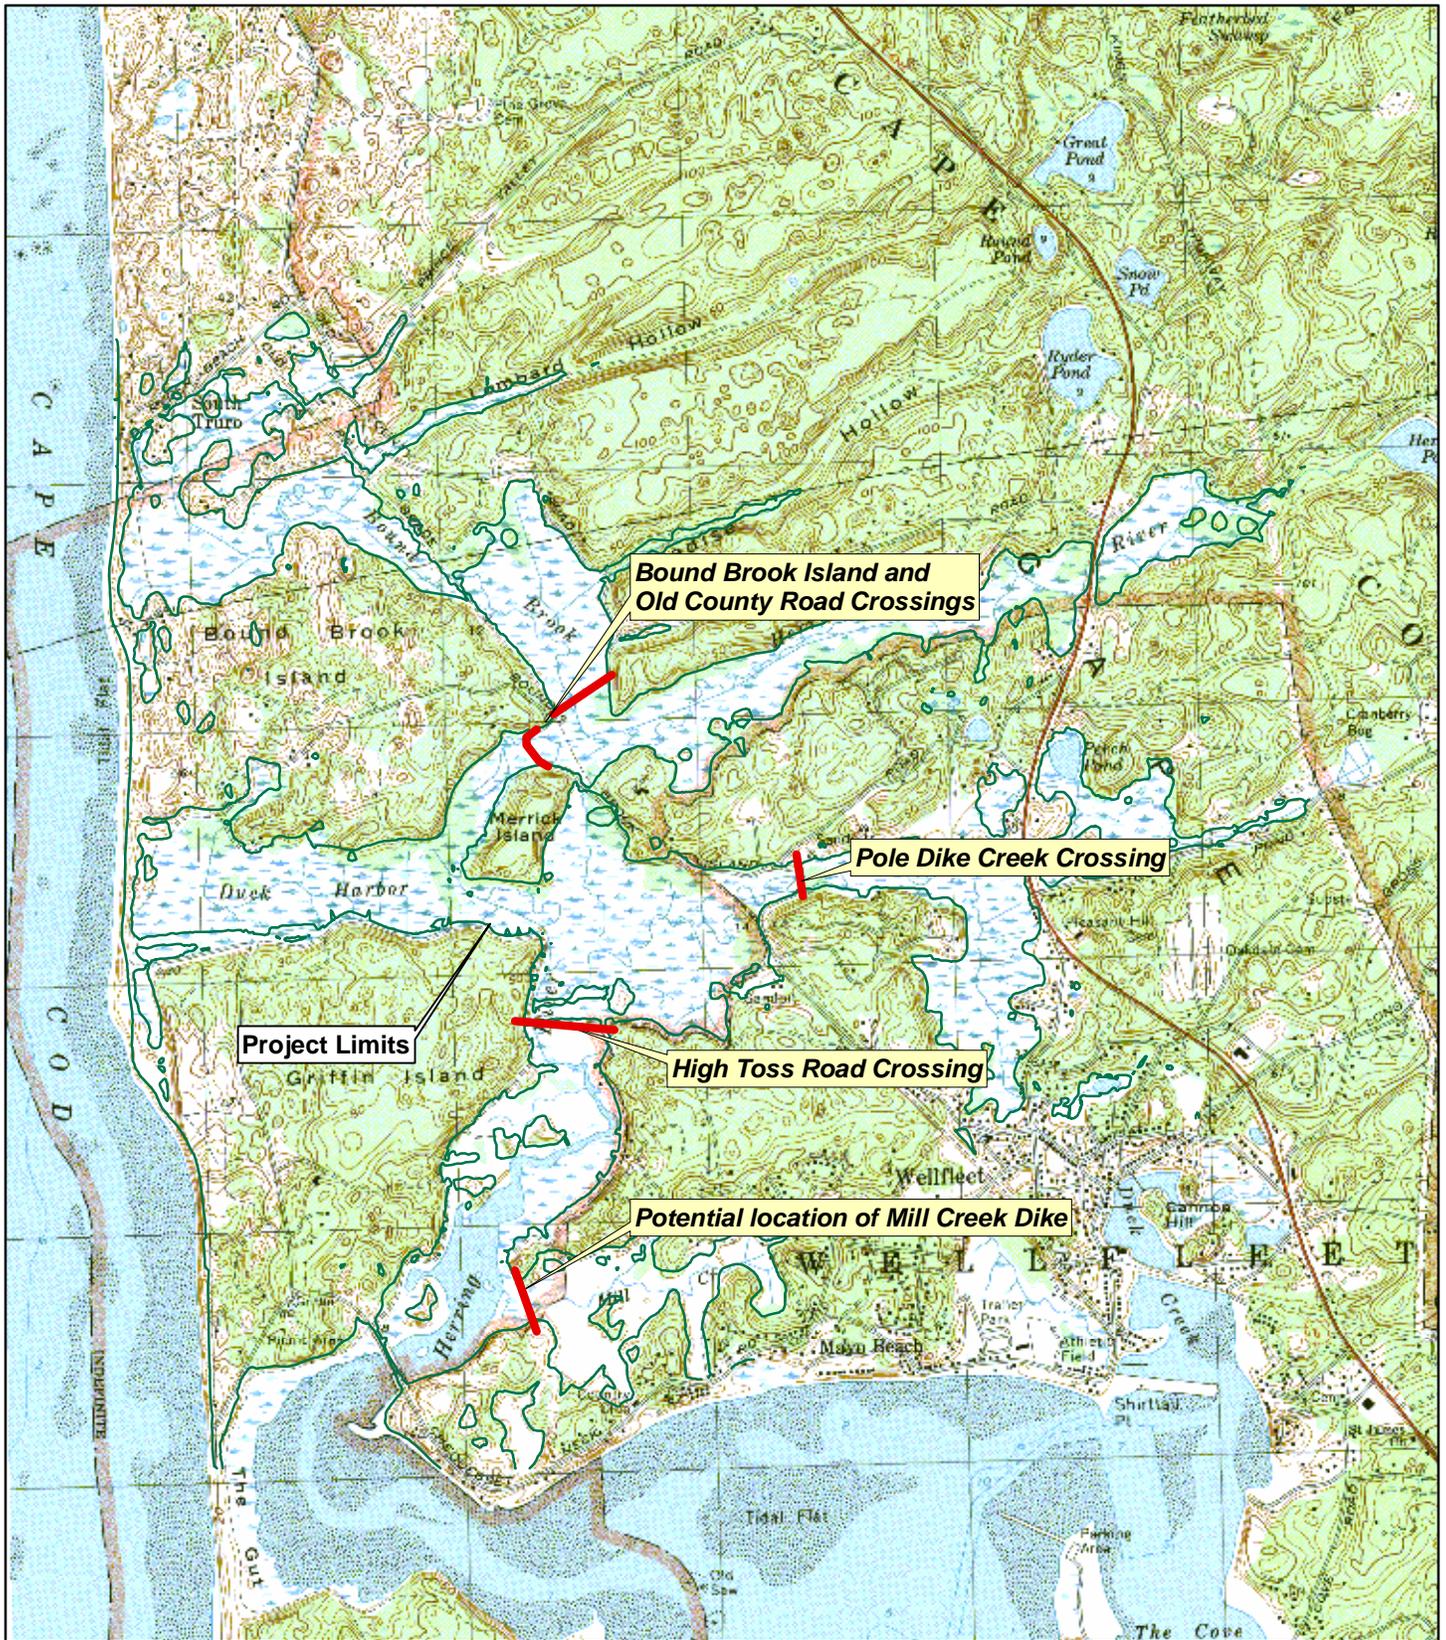
**Potential Upstream Tidegate Control Locations under Open Bridge Alternative**

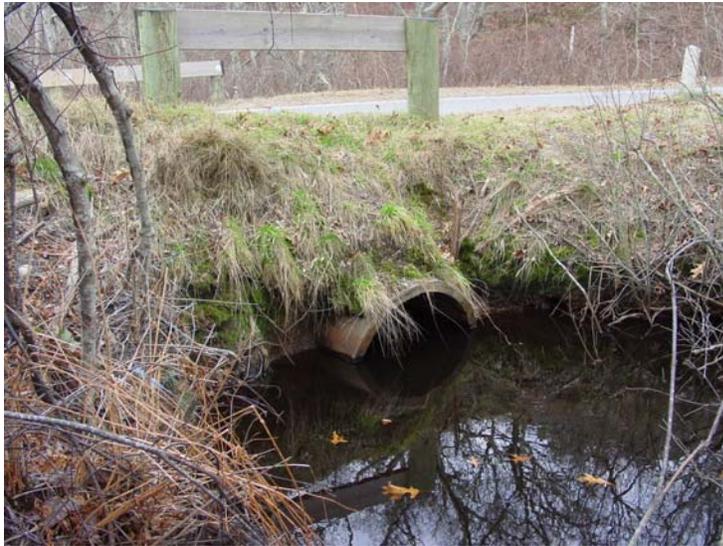
Photo 14: Pole Dike Creek at Pole Dike Road

Pole Dike Road is a frequently traveled, paved public road, the northernmost portion of which crosses Pole Dike Creek (see Photo 14). This portion of roadway, which is a relatively short length of road, is at elevations below 5.0 feet (NAVD 88). The densely vegetated wetland areas that border the creek are close to both margins of the road. Avoiding or minimizing wetland impacts by road relocation or lateral realignment would not be possible here due to both the lack of adjacent land at higher elevations and proximity to existing wetland resource areas (although as noted below, the use of the nearby railroad bed is a consideration). It appears that raising the roadway by the necessary number of feet would result in some amount of wetland alteration from construction of sloped roadway

A 32-inch diameter, 40-foot long culvert conveys Pole Dike Creek beneath the road. Replacing this pipe culvert with a larger conveyance structure, such as an open-bottom arch or box culvert, would alleviate the apparent flow restriction caused by the existing culvert and create better conditions for fish passage. Again, this structure may be considered another control point for regulating tidal inundation within the 172-acre wetland system upstream of this location along Pole Dike Creek.

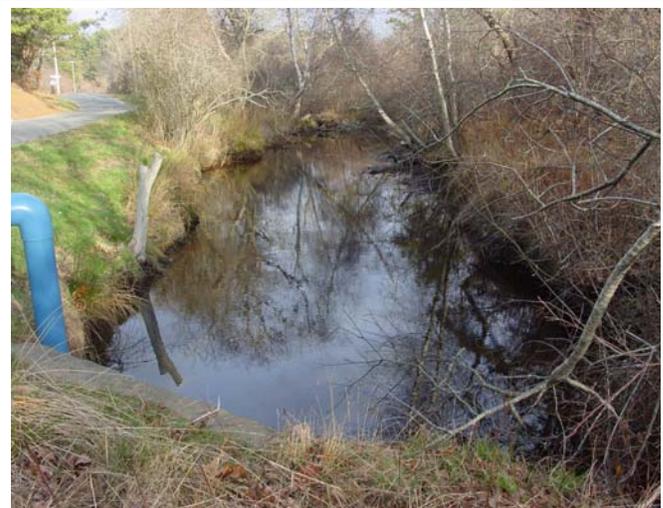
Photo 15: Herring River along Bound Brook Island Road

Bound Brook Island Road crosses the Herring River where the river changes from a north-south orientation to an east-west orientation (see Photo 15). This paved road is frequently traveled as compared to High Toss Road. The 60-inch concrete culvert, which conveys the Herring River beneath Bound Brook Island Road, would very likely impose a flow restriction with tidal restoration at this point along the river.

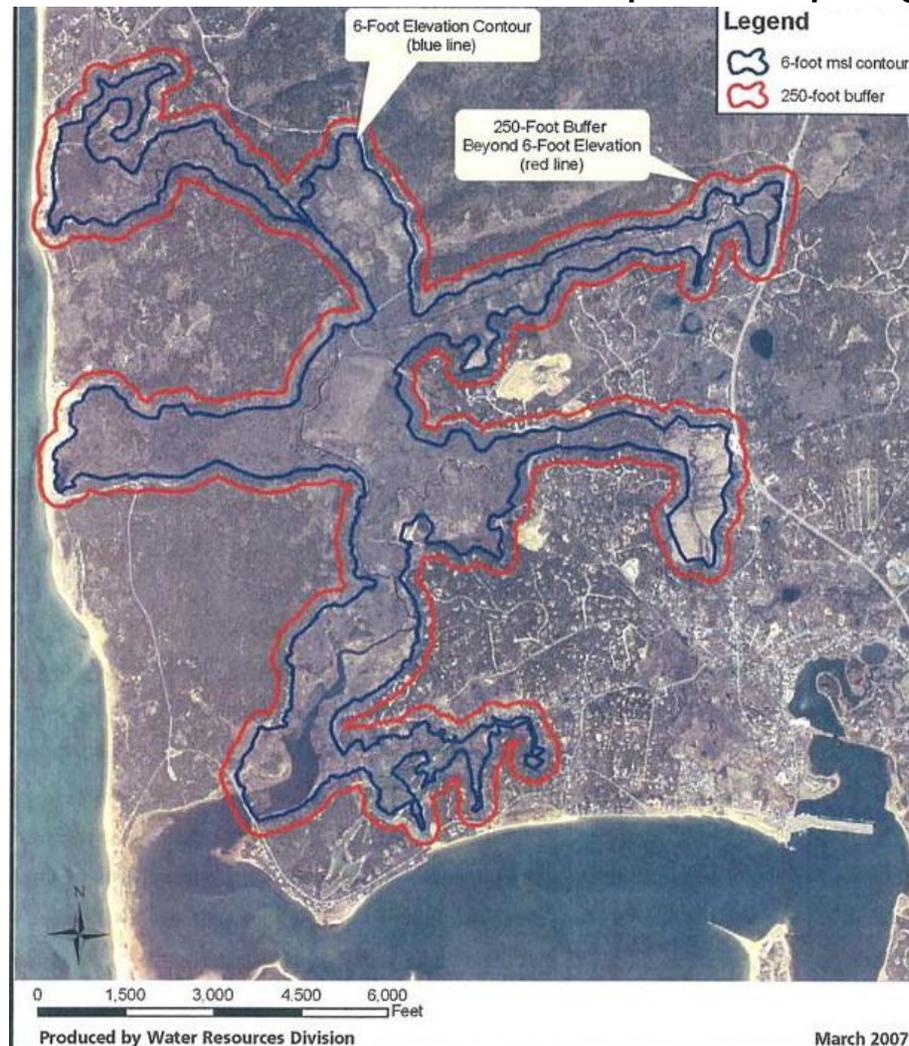
Figure 20. 250-Foot Zone from Anticipated Spring-Tide Elevations

*Examination of water quality results from properties near Herring River and from wells close to other nearby Cape Cod embayments, and computations based on the known relationship between water-table height and the depth of the freshwater aquifer (Martin 2004), concluded that only those properties within 250 feet of the Herring River estuary had any chance of being affected by tidal restoration. Further hydrologic analyses showed that only those wells placed within or very close to the original coastal flood plain (less than ten wells) had the potential for saltwater intrusion with tidal restoration.*
